**West Africa Coastal Areas Management Program (WACA)  
Resilience Investment Project (ResIP, P162337)**

**SOCIAL AUDIT OF THE EMERGENCY PROTECTION SUB-PROJECT**

**Report of the social audit mission**

**15 April 2022**

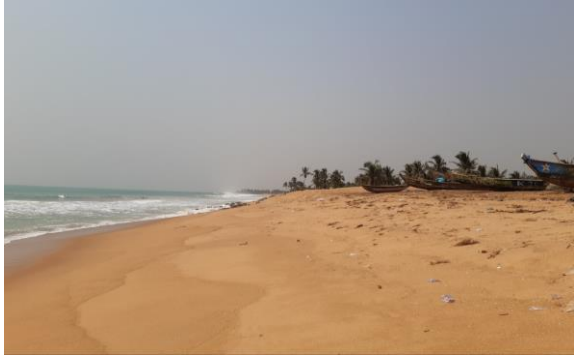
- The eastern part of the pipe wall, including the 50 m corridor, is in good condition with unhindered access, allowing in particular the use of the corridor for the passage of people and boats from the beach to the sea;
- The western part of the wall is damaged, including the 50 m corridor, the use of which is made difficult by the cliff profile on which it is situated, and the pipe segments stranded in the corridor;

Adissem: view of the Eastern corridor from its Eastern border

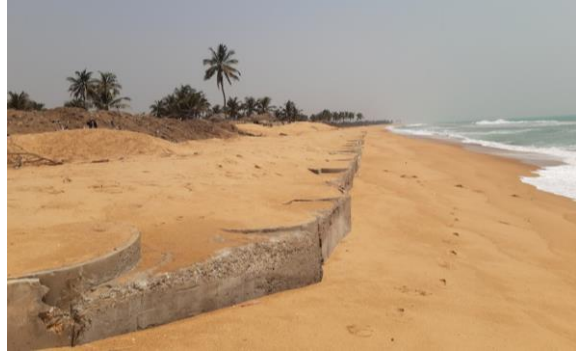
Adissem: view of the extension of the works to the East from the Eastern corridor

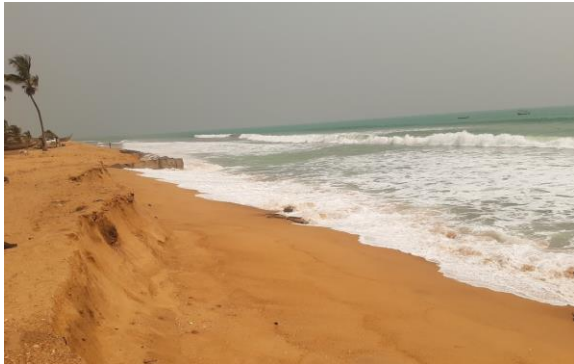
- Stranded pipes are visible on the right foreshore of the central part of the pipe wall and the western corridor and there are others not visible because they have been buried by the sediment. On January 21, 2022, 676 pipes remain on the foreshore but in various states of exposure and sand cover;
- The acceptance of the emergency works by the Adissem community was confirmed during the discussions held during the social audit mission and also by a request from the villagers for an extension of the pipe wall works towards the east in order to protect the cemetery adjacent to the village.

Adissem: view of the Western corridor from its Western border

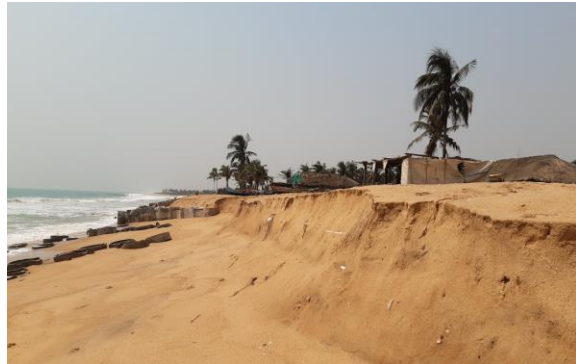
Adissem: view of the Western corridor from its Eastern border

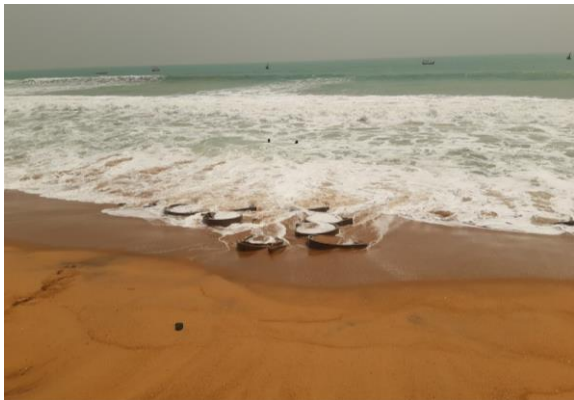
Adissem: view of the segments of pipes stranded in front of the central part with the presence of swimmers

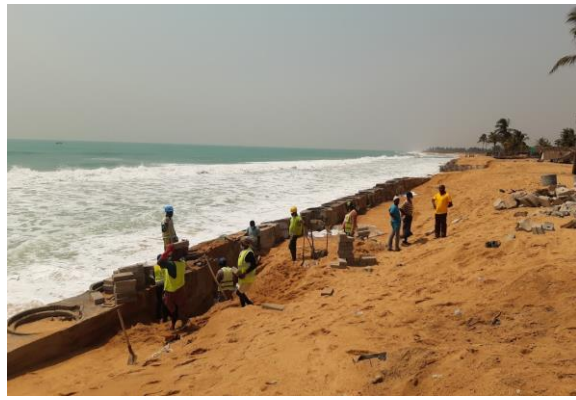
Adissem: central part of the wall being repaired / reinforced

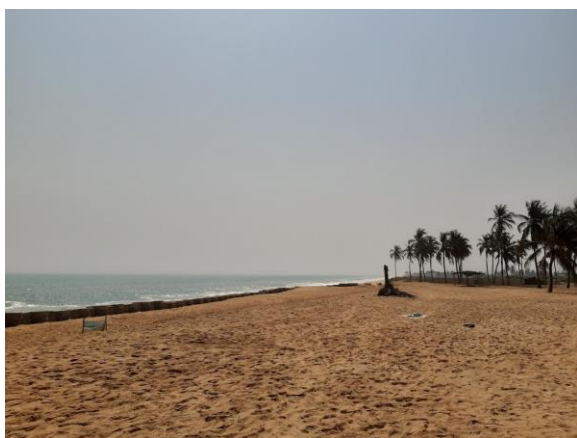
During the field visit, the social audit experts observed that the pipe wall making up the protection works for the village of Tango were well aligned representing a fairly clear physical barrier due to the retention of sand still progressing on both sides of the pipe wall as intended by the original engineering design.

Tango: view of the protection works from the village

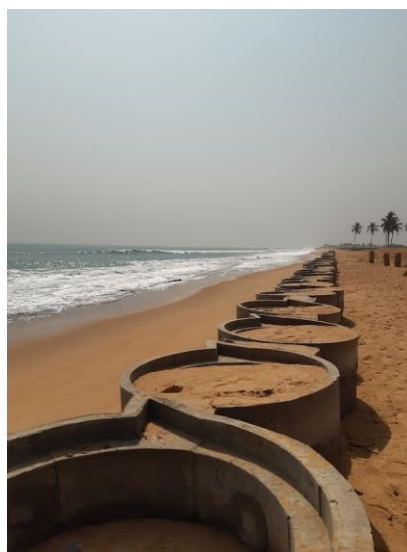
Tango: view of the protection works, with pipes being filled

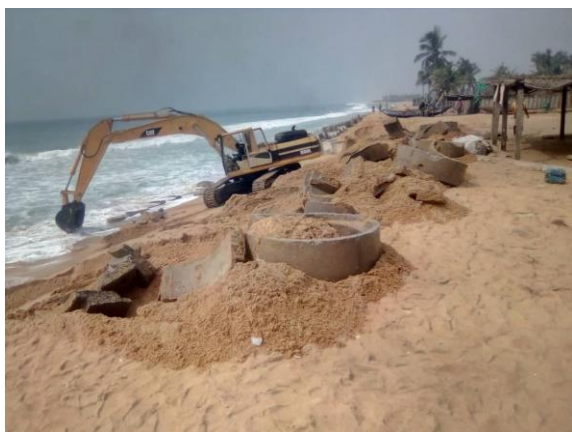
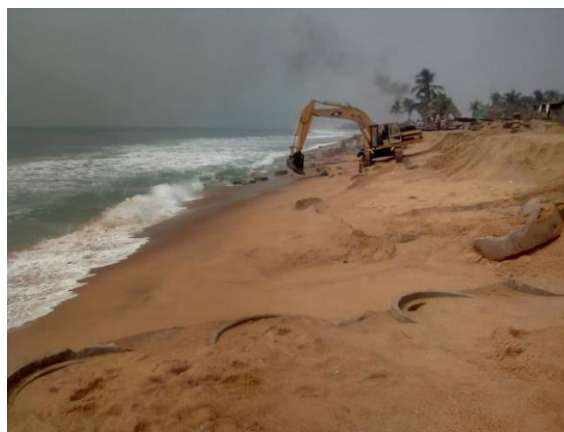
However, the safeguard measures did not include any measures to address the safety of the sites during the works specifically related to: i) the segments of pipes stranded on the foreshore that were partially buried but also partially uncovered; and ii) the risk of collision between the boats and the concrete pipe walls. According to the fishing community of Adissem, there was one accident related to a boat (see section 3.1) but no incidences of collision of boats with the concrete pipe wall have been reported. The stranded pipe segments were removed by the Contractor's excavators, but there was still work to be done as 676 pipes were observed on the foreshore at the time of the visit of the social audit mission.

Adissem: excavator in action on 01/28/2022 to remove pipe segments stranded on the foreshore (Contractor photos)

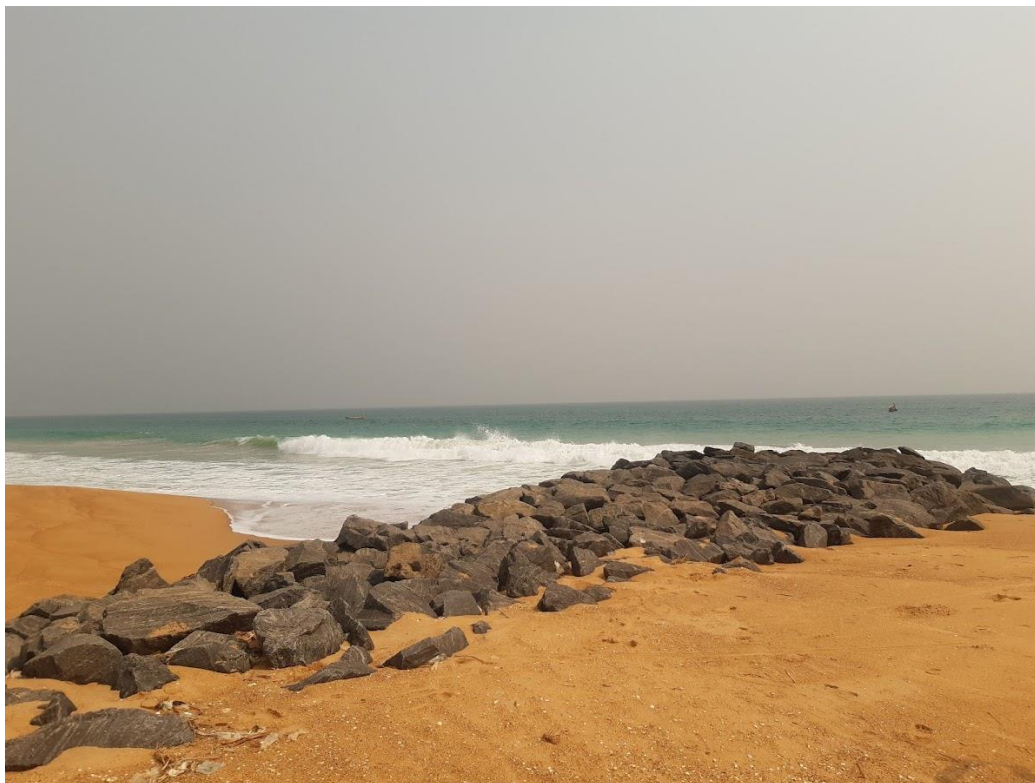
*The visit of the existing groynes at Aného revealed that there is no protection / signaling of the works (see below). Pedestrians have free access to the groynes with the risk of falling between the blocks of rock, and the groynes are not marked, which would have made them more visible from the sea, day and night, and would have reduced the risk of collisions with boats.*

*Aného (East Agbodrafo): view of one of the existing protection groynes  
(construction prior to the WACA intervention)*
