SECOND REPORT AND RECOMMENDATION ON A REQUEST FOR INSPECTION

**WEST AFRICA COASTAL AREAS RESILIENCE
INVESTMENT PROJECT (P162337), ADDITIONAL
FINANCING – WEST AFRICA COASTAL AREAS
RESILIENCE INVESTMENT PROJECT (P176313),
AND GLOBAL ENVIRONMENT FACILITY (P092289)**

JUNE 8, 2022

**The Inspection Panel Second Report and Recommendation
on a
Request for Inspection**

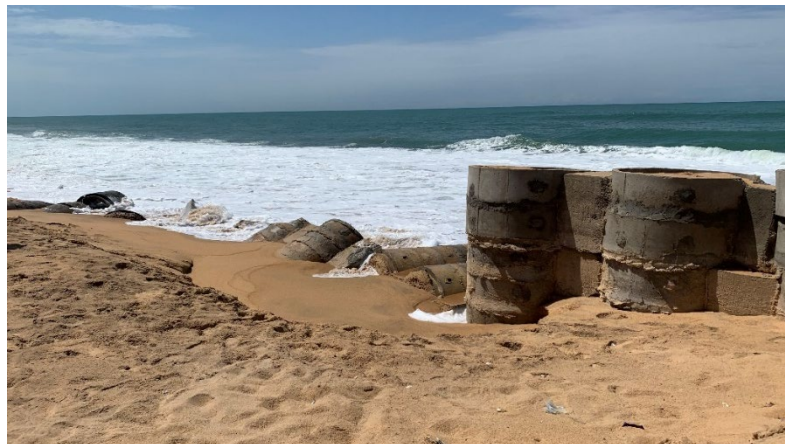
24. The Panel notes that the impact varies for each fishing technique.¹⁹ The Panel observed that for the *Tunga* technique, fishermen need to land smaller boats on the shore while for the *Senne Tournante*, boats are kept at sea. In both cases, fishermen swim to shore at some point, either to guide their crew or pull their boats, or to return to shore. The Panel heard from these fishing communities that the length of the pipe walls has direct implications on their ability to access the sea and conduct fishing activities, which is their main source of livelihood as well as for many of the women in the community.

Picture 1: Collapsed concrete pipe wall in Tango

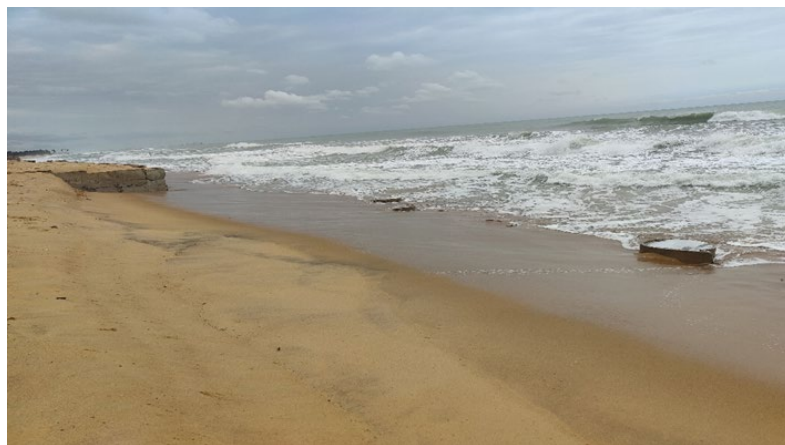
Picture 2: Concrete pipes stranded in the eastern corridor in Adissem.

26. In line with the Audit's observations, the Panel noted that the western section of the pipe wall is damaged and contains stranded pipe segments which the community claims make it very difficult to use for fishing. The Panel, however, observed that the eastern side, which is the only active corridor, also contains stranded pipes blocking the access. In addition, the fishermen of Adissem reported an accident where a fishing boat was damaged attempting to safely enter the eastern corridor. Furthermore, the Panel was told by the fishermen of Adissem that during the period in which the pipes were being built, they were unable to access the sea for approximately two to three months due to the obstacles covering the beach. They stated that during that period they were unable to fish and suffered a loss of income for which they claim they did not receive compensation.

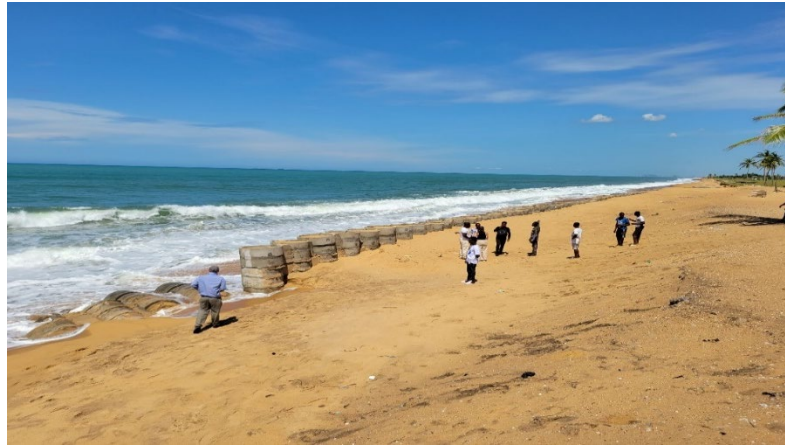
Picture 3: Concrete pipe wall in Tango.

28. Consistent with the Audit, the Panel observed that there is a fishing community in Tango. One of its members indicated that he is no longer able to launch or dock his boat in Tango due to the pipe wall, which, unlike Adissem, does not contain a corridor for that purpose. He showed the Panel his damaged boat alleging that the damage was caused by the pipe wall. The Panel observed that the beach access is blocked off in Tango and that a section on the eastern section of the pipe wall had collapsed and fishermen now must carry their boats 100 meters away from their past access point.

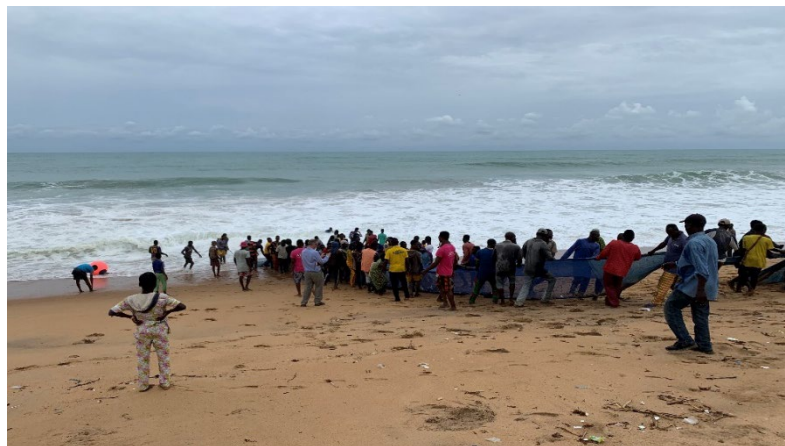
58. Several stakeholders raised concerns about the viability of the *Senne de Plage* once the groynes are installed. The Panel observed a *Senne de Plage* in Kpémé. The technique is still performed in Kpémé and Aného crossing the existing groynes, which are in need of rehabilitation. However, several fishermen the Panel met with indicated that the groynes pose several risks, such as: torn fishnets and injuries caused by pulling the net across the groynes. On the other hand, fishermen from other communities informed the Panel that they believe the *Senne de Plage* will no longer be possible once the groynes are installed or the existing ones rehabilitated. The Panel met with government officials who indicated that *Senne de Plage* may no longer be possible and that fishermen should transition to other types of fishing techniques.

Picture 4: *Senne de Plage* technique in Kpémé.

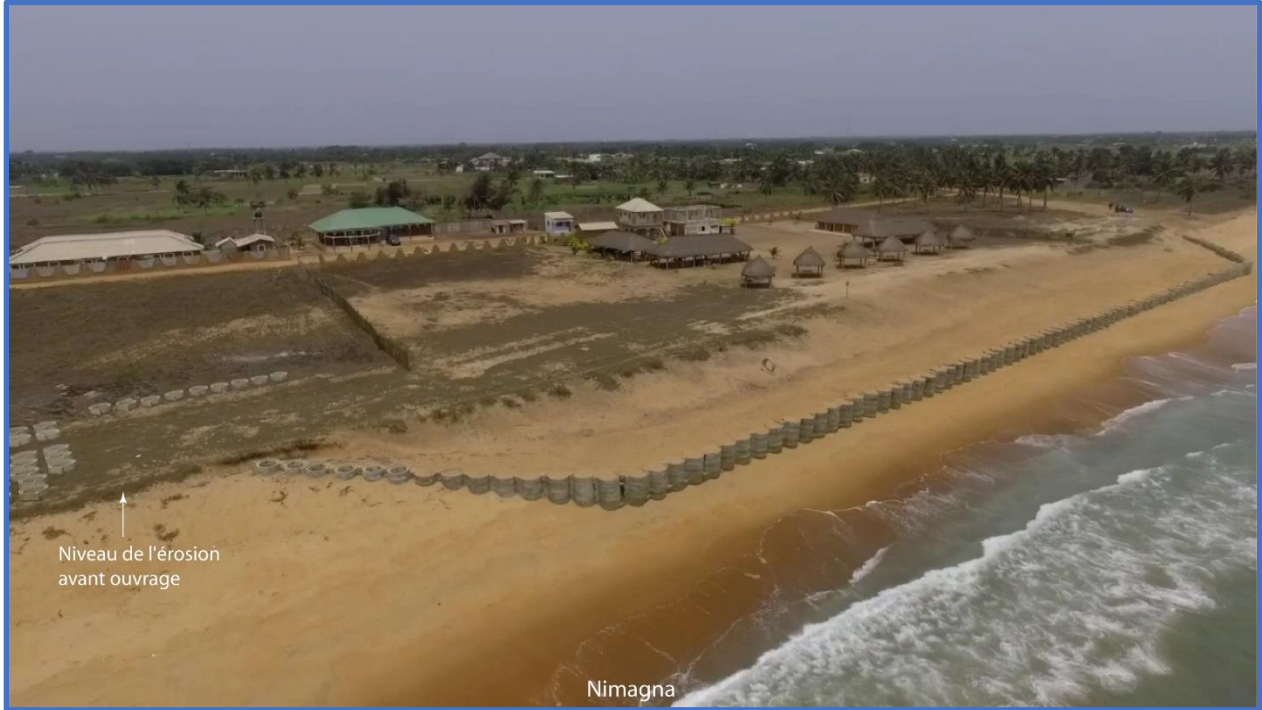
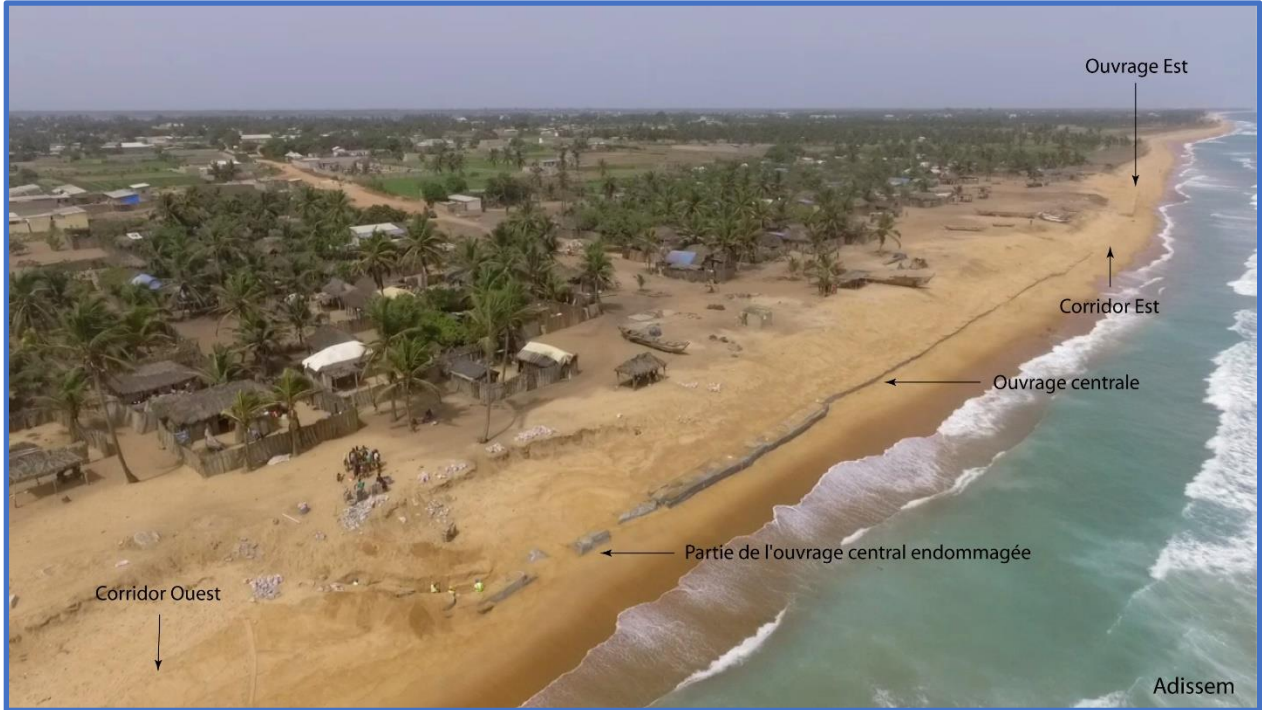
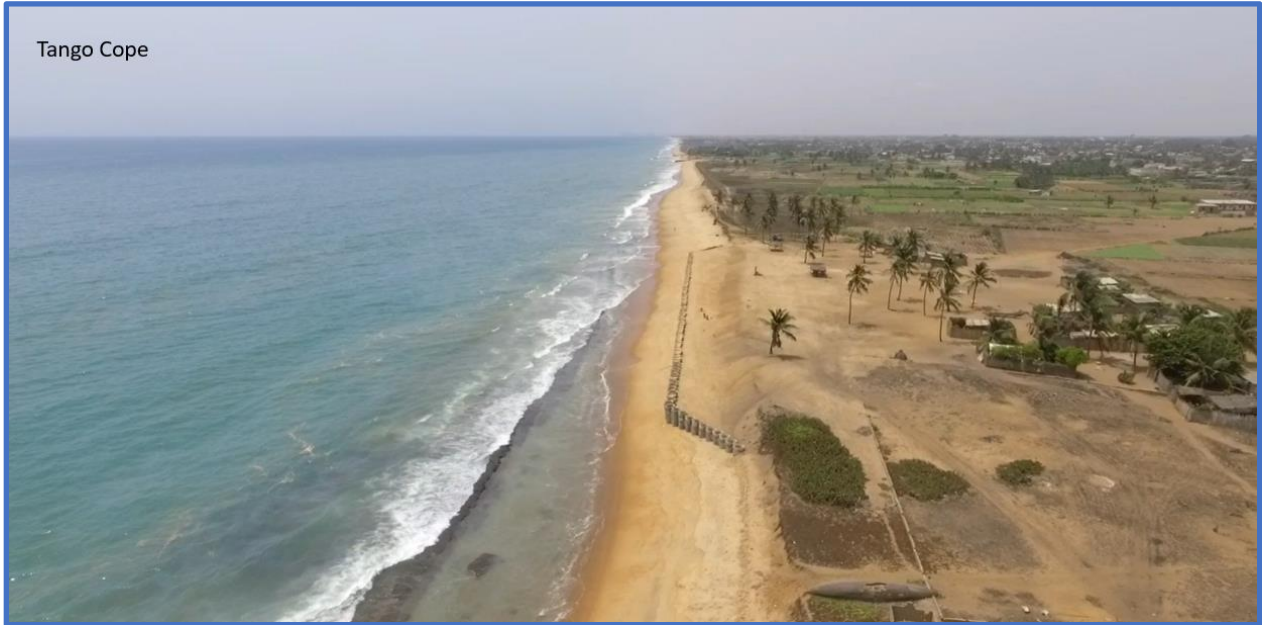
Annex 2: Drone Photos from Emergency Works Sites (February 24, 2022)

Tango Cope

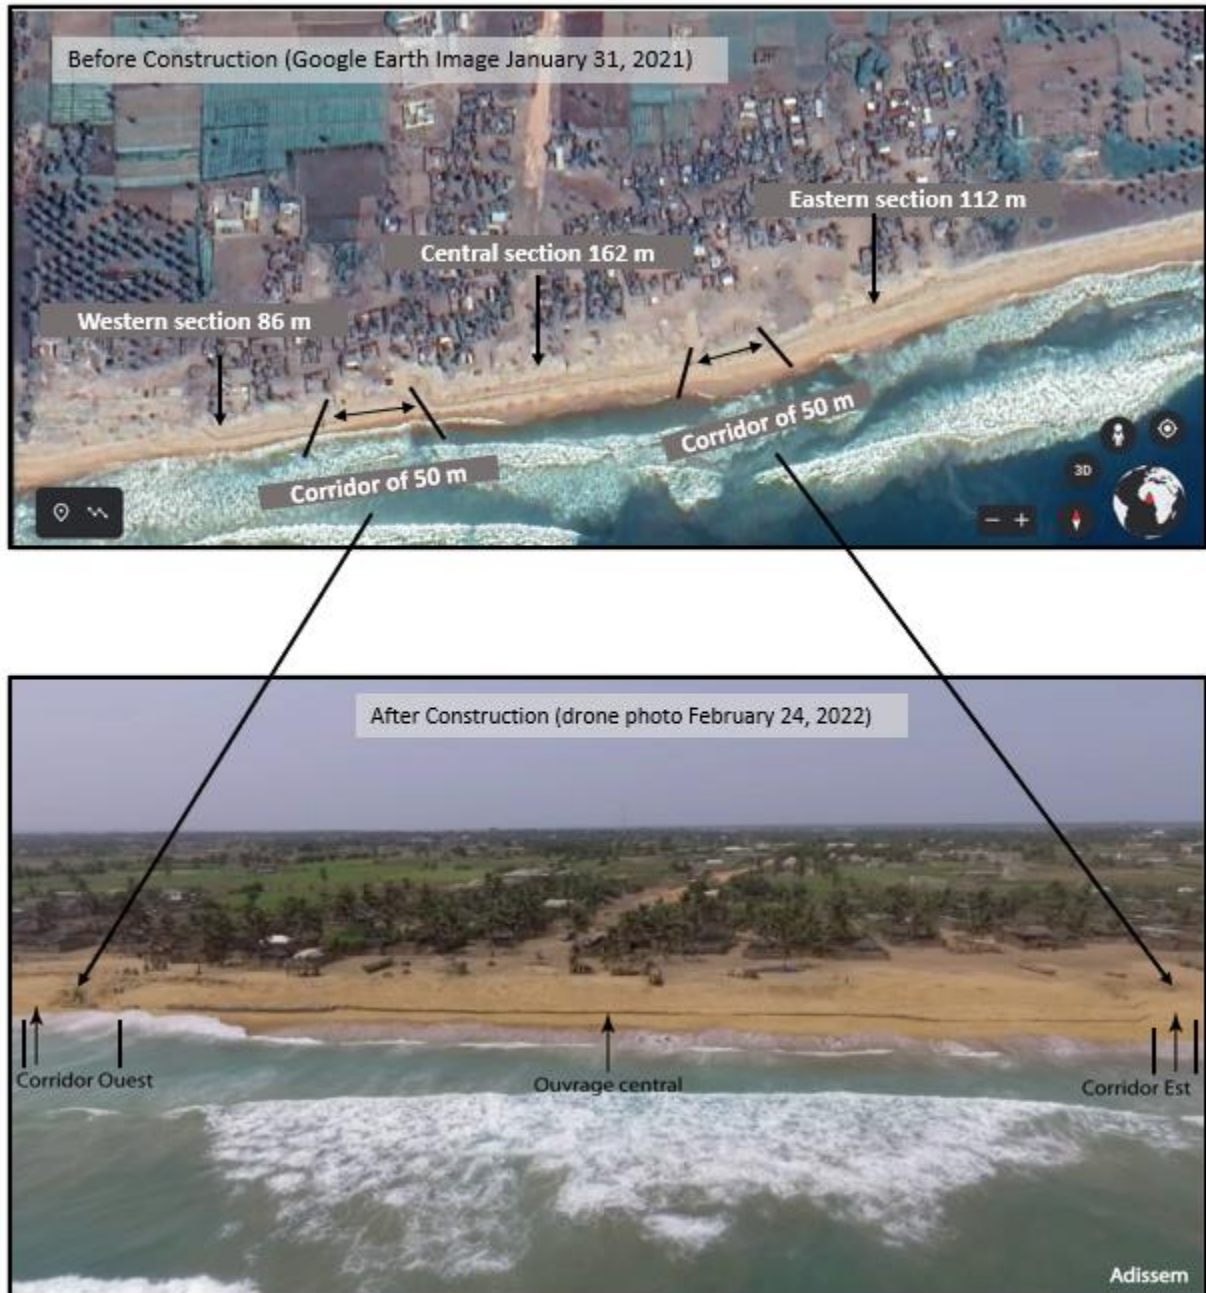
Annex 3: Photo of Boat Landing Corridors in Adissem

25. The Social Audit reported that the Project created two 50-meter corridors in the emergency protection pipe wall in Adissem. The Audit noted that the corridor located in the western section of the pipe wall is damaged and contains stranded pipe segments which make it very difficult to use the corridor for the launching and berthing or docking of boats.²⁰ However, on the eastern side of the pipe wall, the Audit found the pipes to be in good condition and indicated that there was unhindered access and egress for boats to berth or land on the shore. The Audit also reported stranded pipes visible on the right foreshore²¹ of the central part of the pipe wall.²² According to the Social Audit, the community requested the extension of the pipe wall works towards the east in order to protect the cemetery adjacent to the village.²³ The Social Audit further noted that no complaints had been recorded in Adissem regarding possible loss of income resulting from a reduction in the fishing activity of the community, due to the obstacles created by the works.²⁴ The Audit points out that the village population confirmed its satisfaction with the works.²⁵

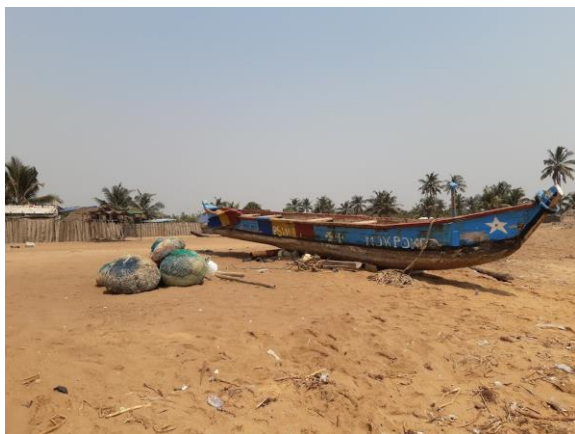
Adissem : Big boat used in the *senne tournante* fishing technique (in technical stop)

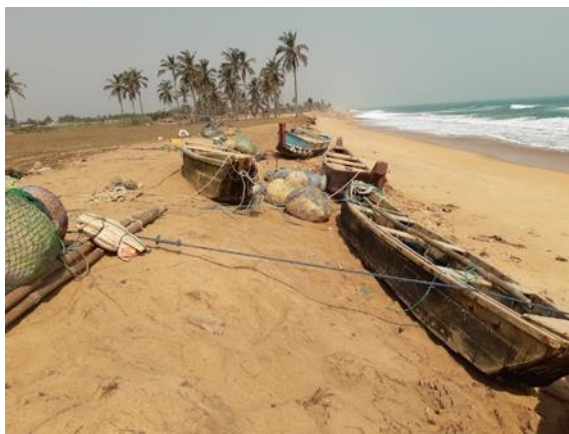
Tango : Small boats used in the *filet maillant* fishing technique

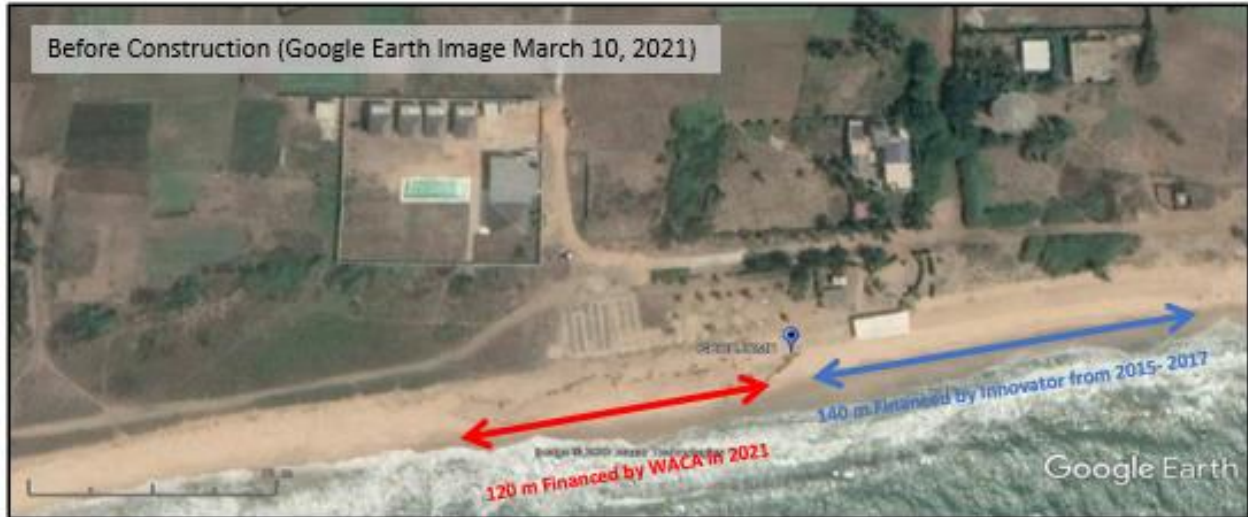
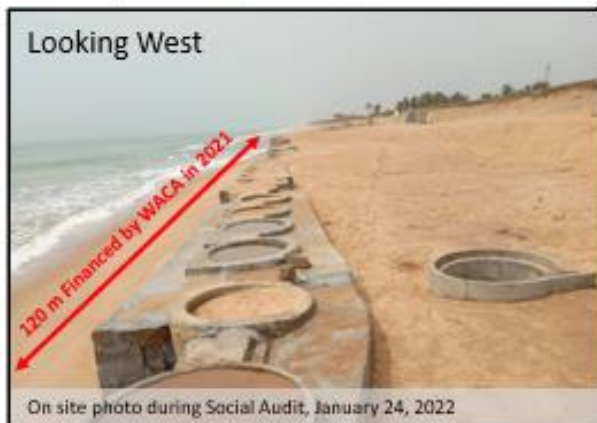
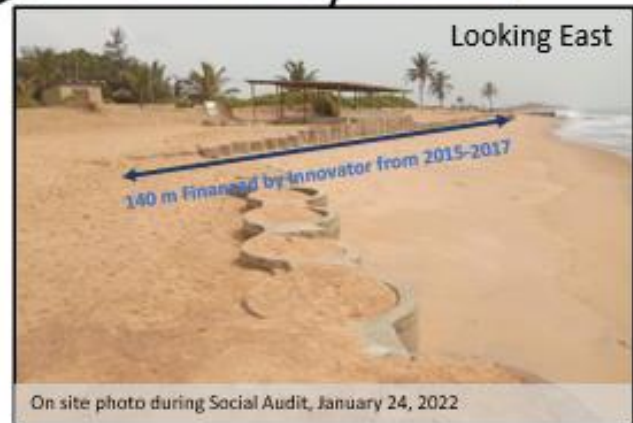
Gbodjomé

Geo location: 6.1859545° N 1.4123653° E

Purpose of construction: Protection of houses, and research and development

29. The Panel saw stranded concrete pipes and pipe walls with similar issues in the villages of Dévikiomé and Gbodjomé, which the fishing communities claim causes harm to them in the form of: damaged boats, torn nets, access and time restriction at sea, and increased risk of injury to the fishermen and community members. The Panel notes that some of these harms are temporary while others may be of a more permanent nature, depending on (i) the frequency and effectiveness of the maintenance works, and (ii) how long the emergency measures are maintained in place.

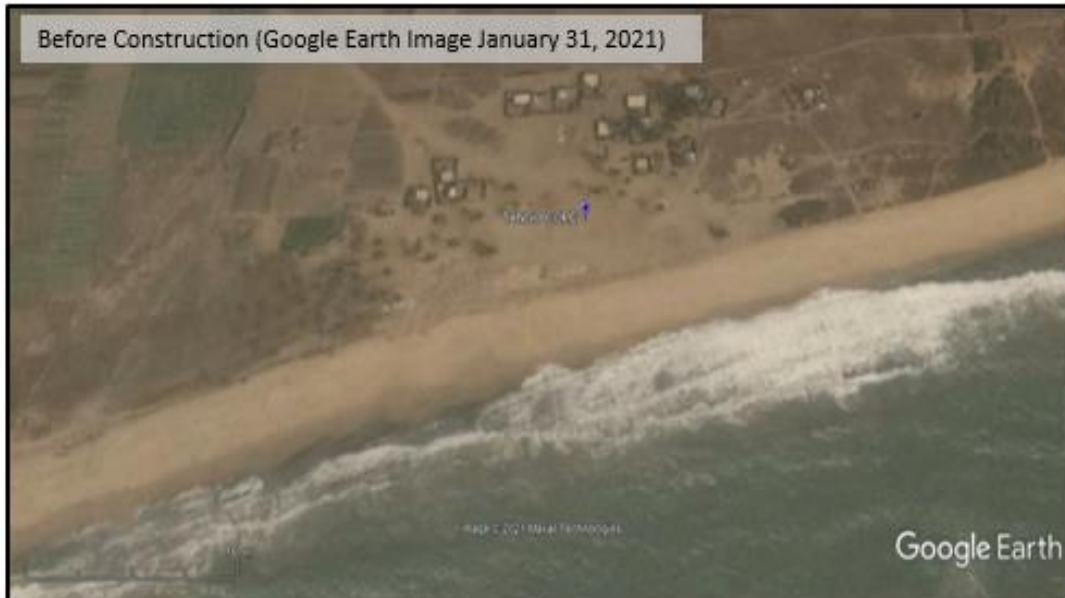
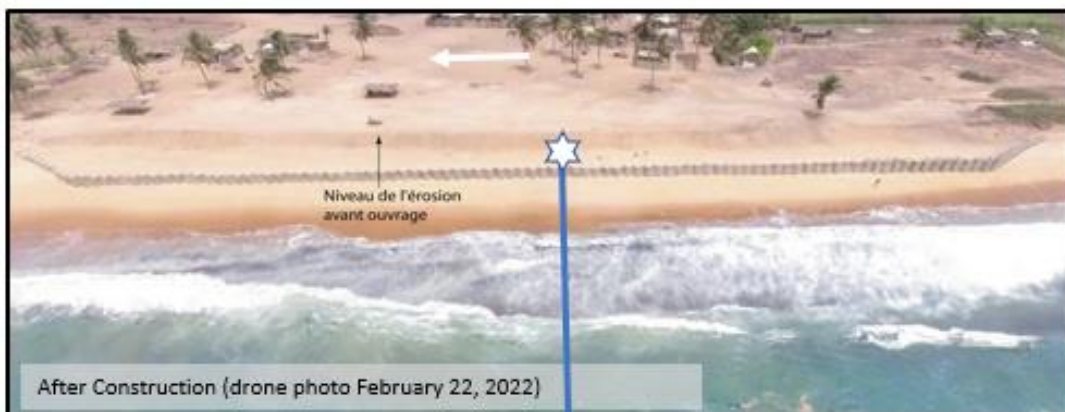
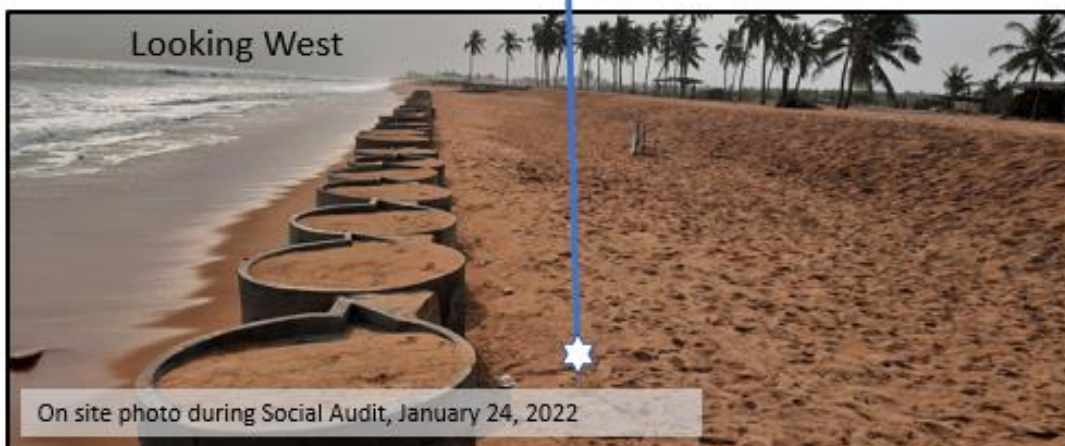
Tango Copé

Geo location: 6°11'20.52"N 1°25'21.43"E

Purpose of construction: Protection of fishing village (190 meter)

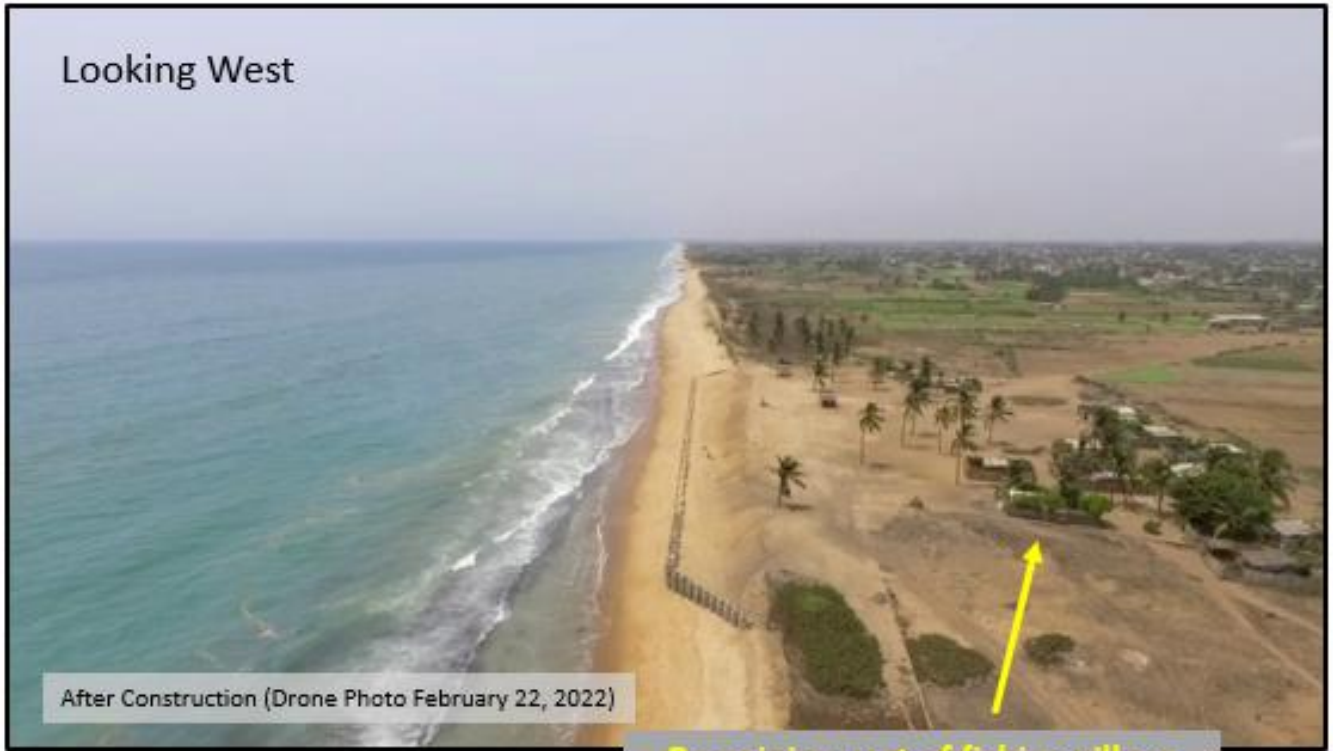
Looking West

After Construction (Drone Photo February 22, 2022)

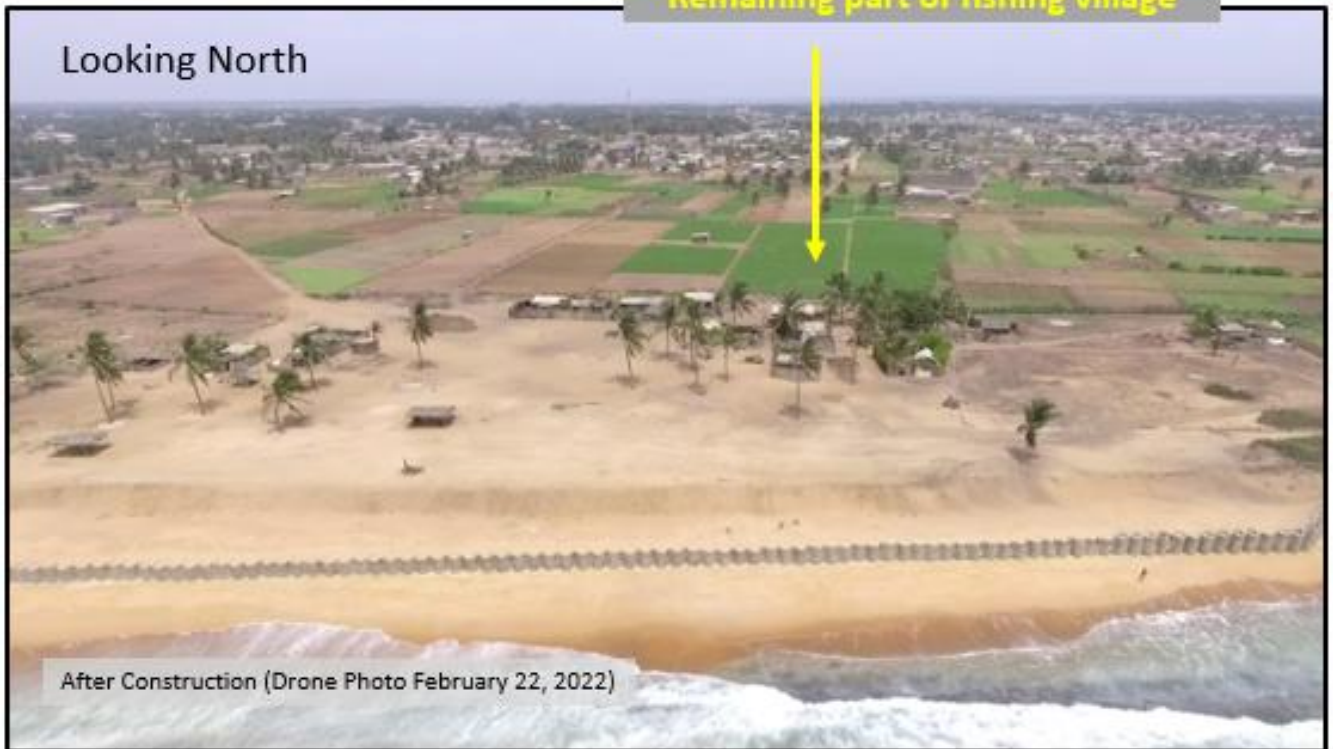
Remaining part of fishing village

Looking North

After Construction (Drone Photo February 22, 2022)

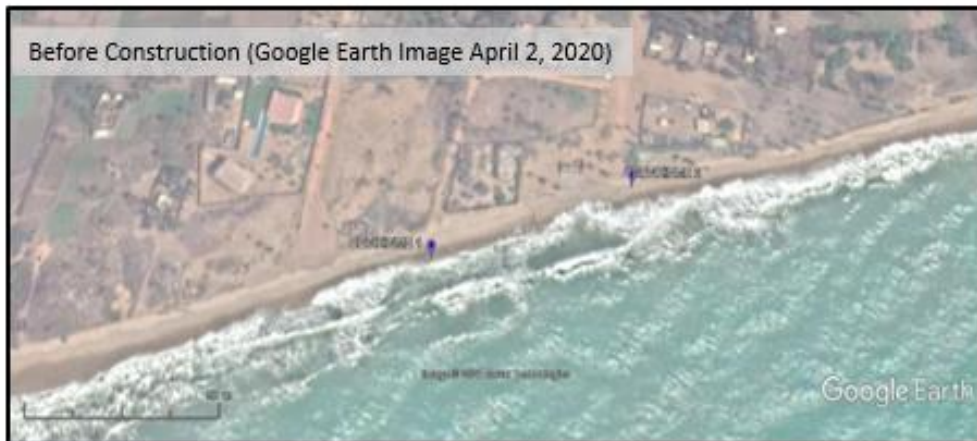
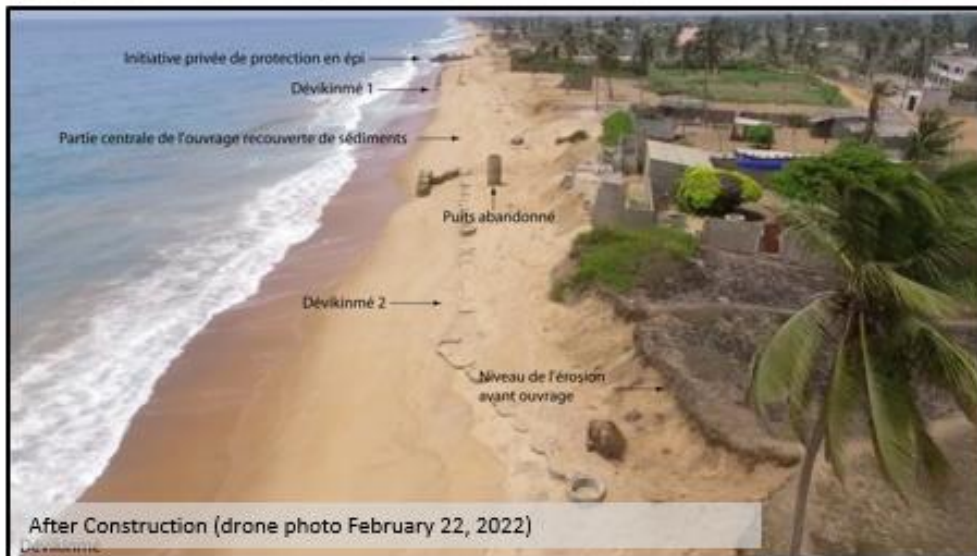
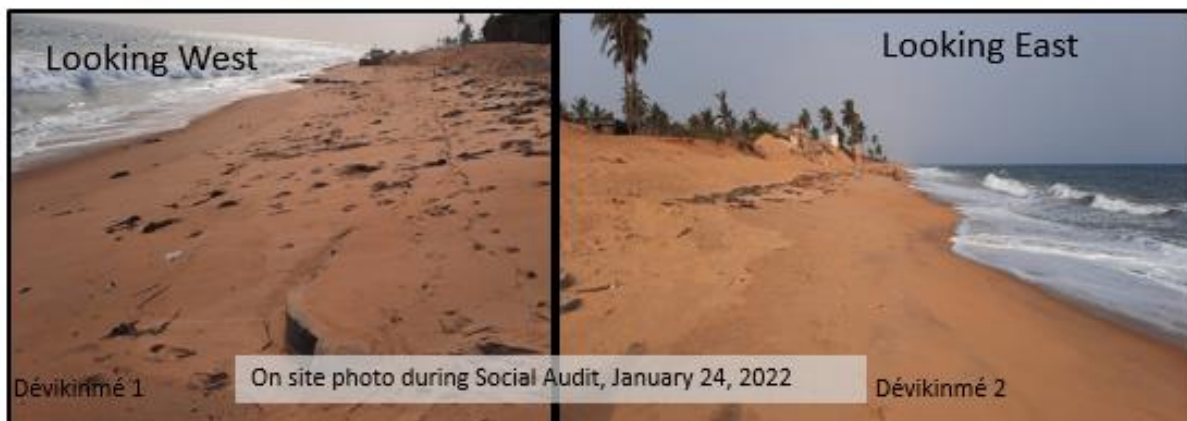
Geo location: 6°11'23.40"N 1°25'37.52"E

Purpose of construction: Protection of the remaining part of a fishing village, which had lost 2-300 meter of beach front to coastal erosion (only the former well is visible now).

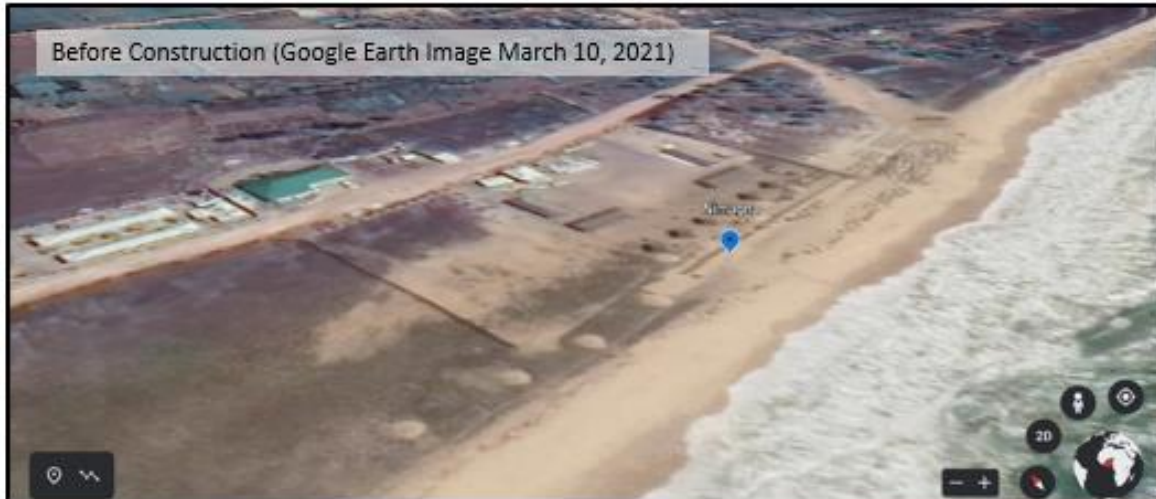
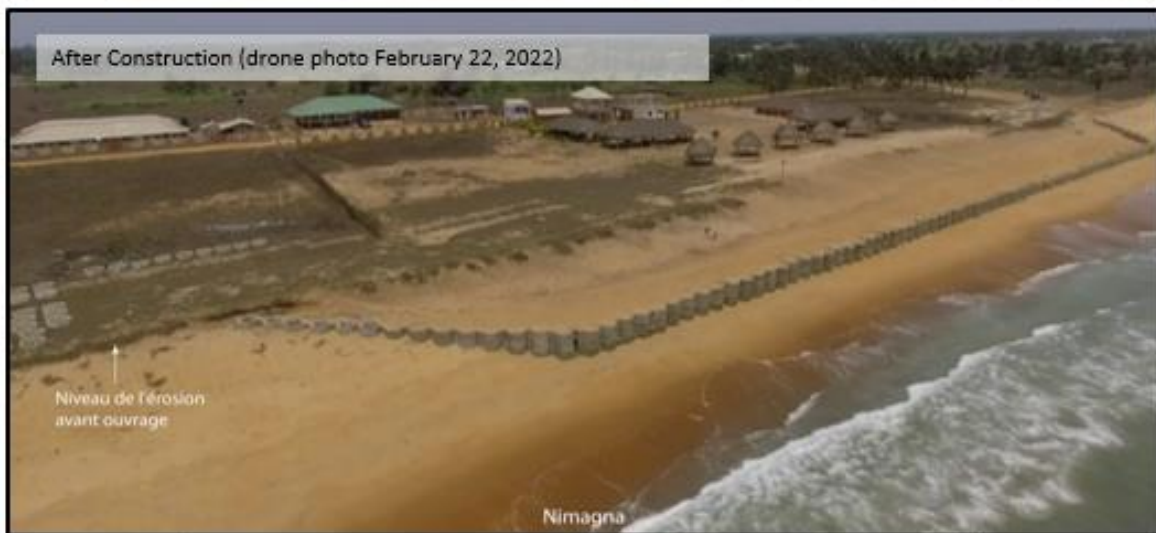
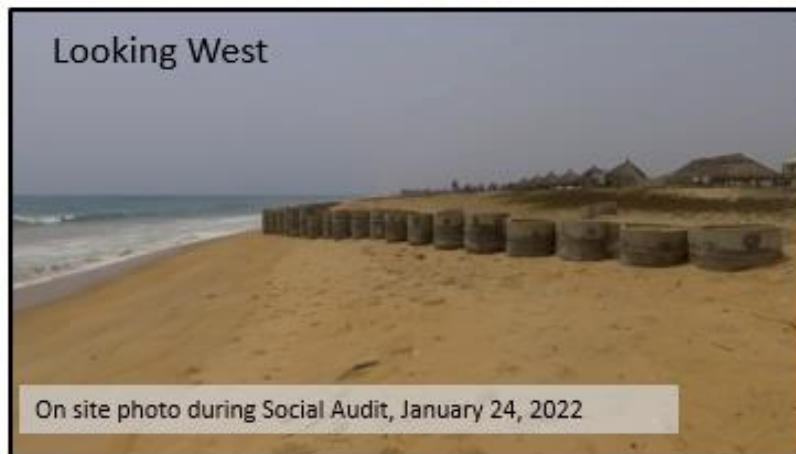
Nimagna

Geo location: 6°11'35.08"N 1°26'24.02"E

Purpose of construction: Protection of local economic interest (a hotel), 180 m,

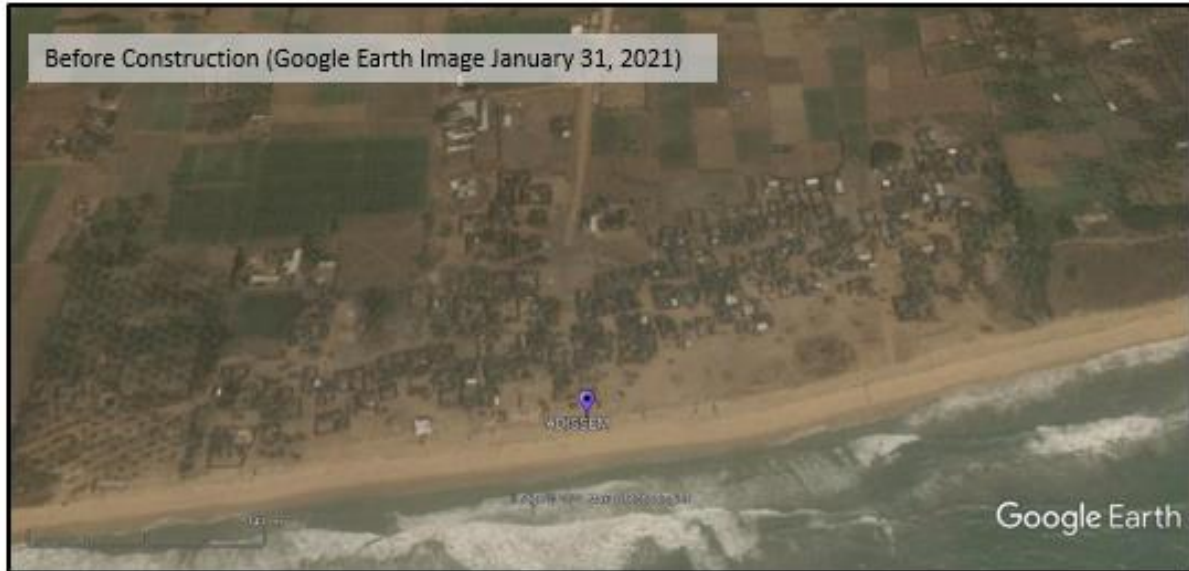
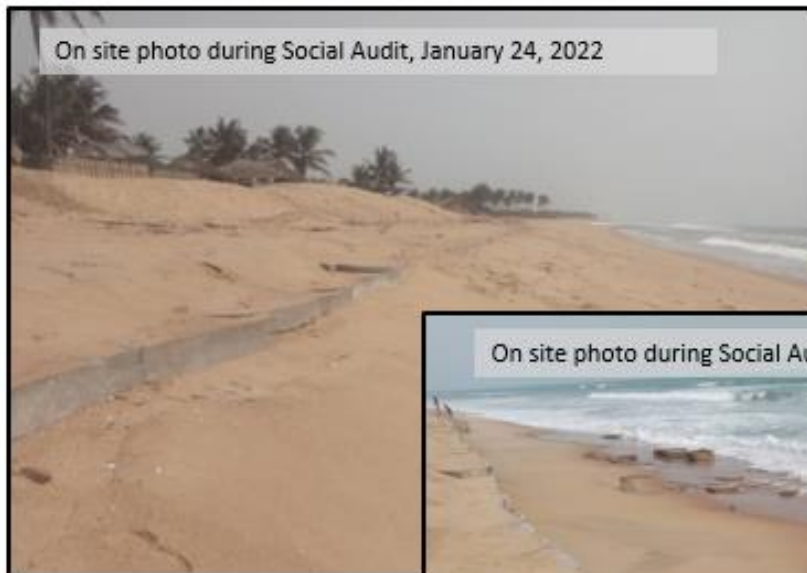
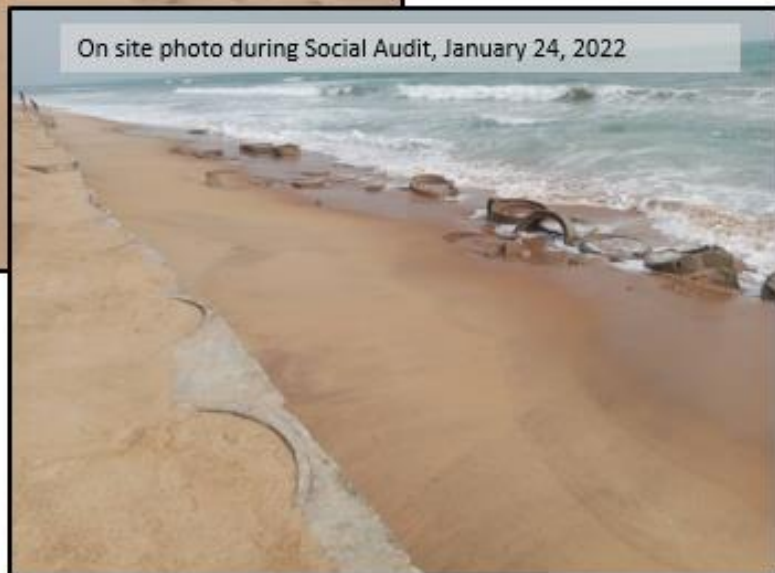
Adissem

Geo location: 6°11'45.88"N 1°27'10.54"E

Purpose of construction: Protection of 500 m, and research and development Special
