PROGRESS REPORT  
TO THE BOARD OF EXECUTIVE DIRECTORS  
ON THE IMPLEMENTATION OF THE MANAGEMENT ACTIONS  
IN RESPONSE TO THE

CHILE  
EMISSIONS REDUCTION PURCHASE AGREEMENT

OFFERED TO COLBÚN FOR THE  
QUILLECO HYDROPOWER PROJECT  
(TRUST FUND NO. TF056272-CL)

April 12, 2011

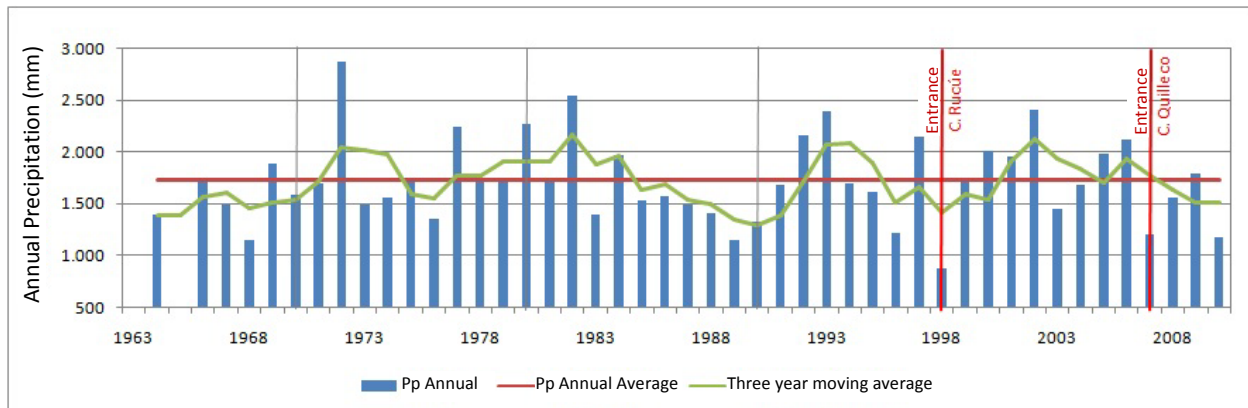
**Figure 6: Annual Precipitation at the Trupán Meteorology Station**

32. *The reductions in the water level in the wells, if any, and the rate of flow in springs flowing off the face of the 100 m high escarpment, are most likely explained by decreased rates of recharge from precipitation in the past few years.* Over the last 10 years there has not been a significant change in the annual precipitation in comparison to the previous four decades (data are available as of 1964). However, 2007, when Quilleco began operation, and 2010 had the lowest annual precipitation in the last decade and were among the lowest eight percent for precipitation over the past 47 years. As shown in Figure 6, these two severe drought years have had a noticeable effect on the three-year moving average, which has been decreasing since 2006. There was also a severe drought in 1998, the year Rucúe began operation. This data would explain a decrease in the recharge rate of the aquifer. Moreover, local residents report that the pattern of precipitation has changed in recent years, with more intense rain falling in a smaller number of events. Such changes in the pattern of rainfall would not appear in data reporting either annual or monthly rainfall totals, but if local residents' perceptions are correct, this change in rainfall pattern also would have a significant effect on recharge of the aquifer.

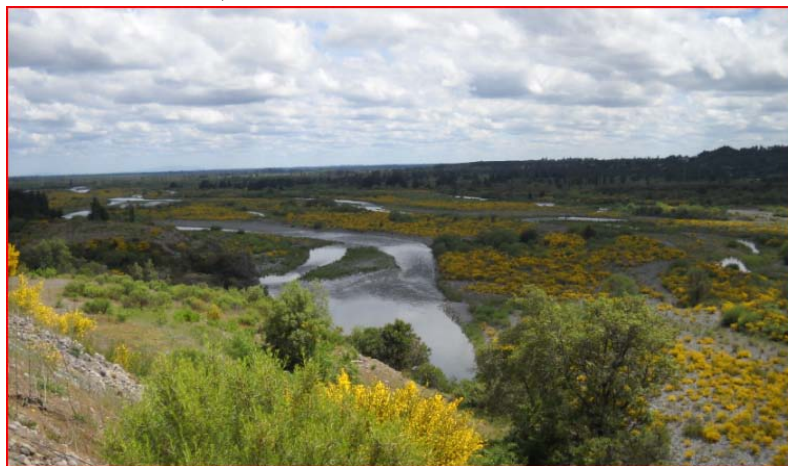
**Figure 7: Braided river channels of the Laja River**

35. *In understanding the results of the study on river morphology, it is important to recognize that the river channel in the vicinity of the Quilleco and Rucúe Projects is a braided system, which is inherently dynamic.* This means that water does not always flow in the same single long-term channel; this is seen in Figure 7 below. Instead, the water may flow in multiple channels across a broad floodplain, often shifting location over time, and merging and splitting depending on recent deposition of sand, gravel, or debris forming temporary or, in some cases, persistent low islands. As indicated in paragraph 5, one of the concerns raised by local residents in the Valle del Laja Community is that islands on the northern “side” of the Laja floodplain, which they consider to be part of their farms, no longer support pasture or serve as locations to plant crops. Residents report that these islands in the northern part of the floodplain have been sterile in the past 10 to 15 years, characterized by sand and gravel rather than fertile soils.

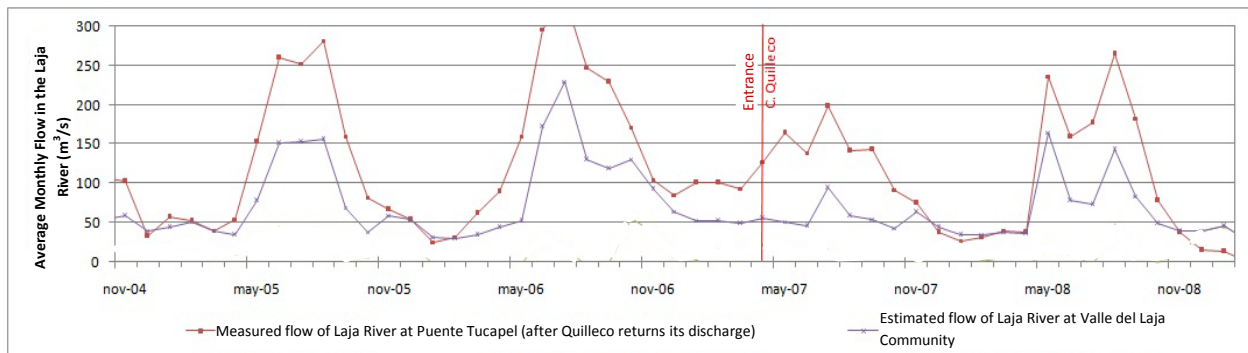
**Figure 9: Flow Pattern in Laja River**

41. The relatively small change in flow volumes in the Valle del Laja area before and after Quilleco operations began in April 2007 is illustrated in Figure 9. The upper trace in Figure 9 shows average monthly flow as measured at the Tucapel Bridge, a short distance downstream of the Valle del Laja area. The bottom trace shows the estimated average monthly flow in the Valle del Laja area based on the sum of contributions from upstream tributary sources, approved extractions for irrigation, power generation at Rucúe and Quilleco, and other purposes. The figure indicates that there is not a major difference in the flow pattern (i.e. the amount and timing of maximum and minimum flows) before and after Quilleco began operation (which, as indicated in paragraph 45, has not had a discernible impact on the Community).

40. ***Operation of the Quilleco Project has reduced the volume of discharge from the Rucúe tailrace, which formerly was returned to the Laja River just upstream of the Sector de Islas.*** The study established that the operation of the Project has reduced the mean annual flow in the study area from 78 to 50 m<sup>3</sup>/s (106 to 59m<sup>3</sup>/s in winter and 50 to 37m<sup>3</sup>/s in summer). These data demonstrate that the reduction in mean flows is not large, especially in the dry season (and, as explained in Section B, has not affected the livelihood of the Community). The mean of 50m<sup>3</sup>/s is over ten times the approved Minimum Ecological Flow (MEF) of 4.6 m<sup>3</sup>/s (see Figure 9).
