REPORT No. 177235-IN

THE INSPECTION PANEL

**REPORT AND RECOMMENDATION
ON A REQUEST FOR INSPECTION**

**VISHNUGAD PIPALKOTI HYDRO ELECTRIC
PROJECT (P096124)
THIRD REQUEST FOR INSPECTION**

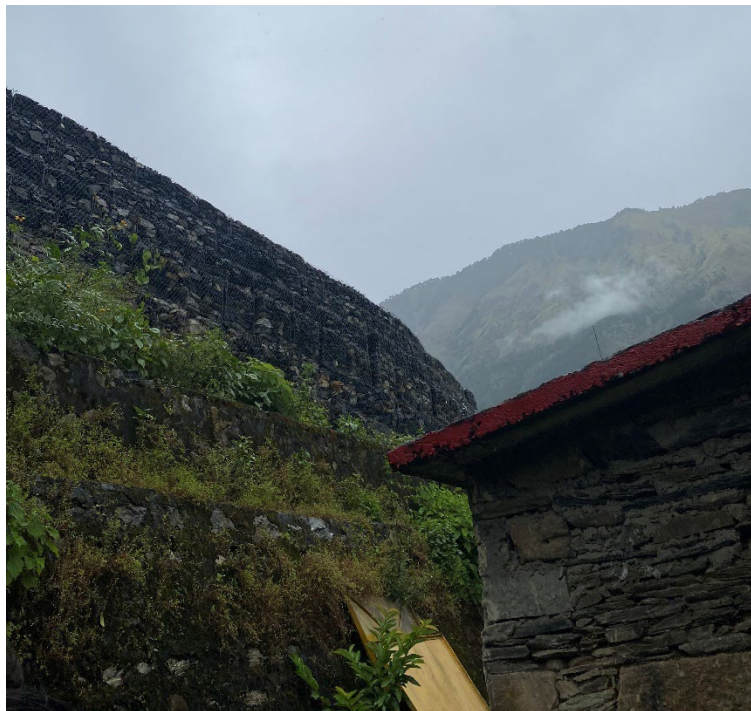
the stones of the original structure. The Panel notes that there is about three meters between the Temple and its compound wall, and a few more meters between this wall and the gabion wall (see Picture 1).

Picture 1: The gabion wall and the Temple's compound wall below it.

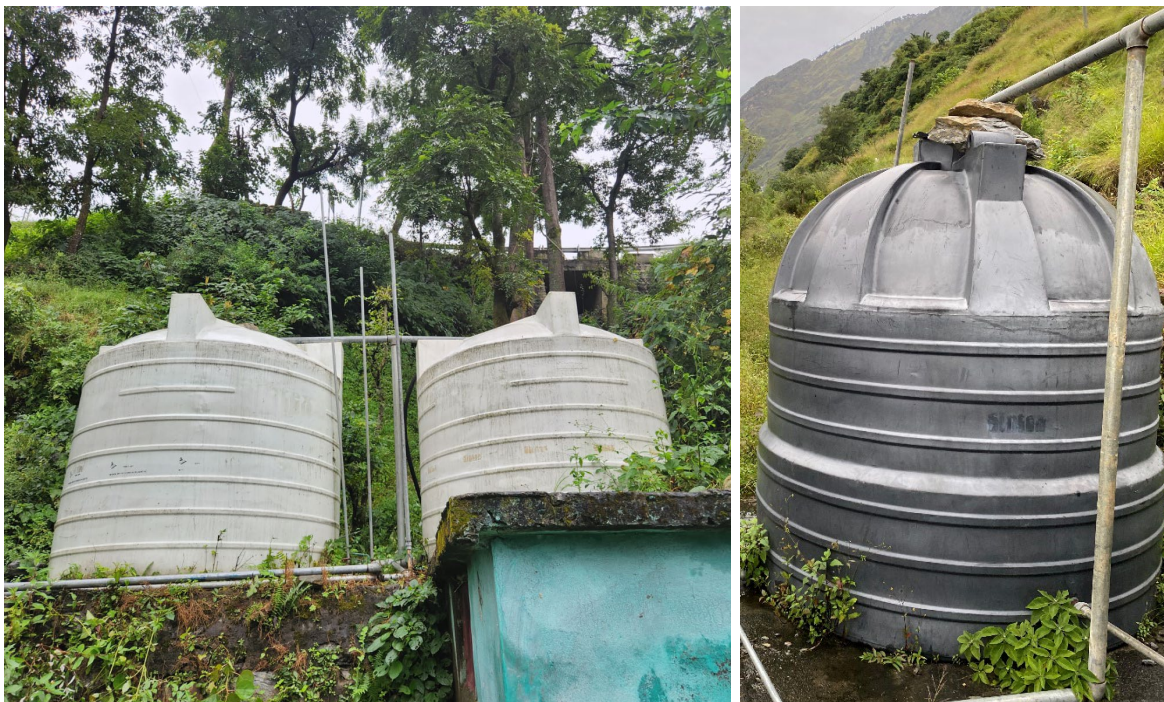
72. THDC officials informed the Team that they had provided four 5,000-liter storage tanks in Eldana and two additional 6,000-liter tanks in Daswana, which has a smaller population. The officials estimated that this much water should provide each household with 810 liters of water, or 185 liters per capita per day. They emphasized that this was more than three times the State-prescribed minimum supply of water, which is 55 liters per capita per day. The THDC officials indicated that the company provides a water bowser when it is informed by a community member that water is needed. They added that this occurred on average once per week. THDC officials informed the Team that the company plans to increase the water pipe's diameter and that the tender process had started. Furthermore, THDC officials stated that the company had engaged the State water authority to explore a more permanent solution.

Picture 3: Water tanks in Eldana and Daswana.

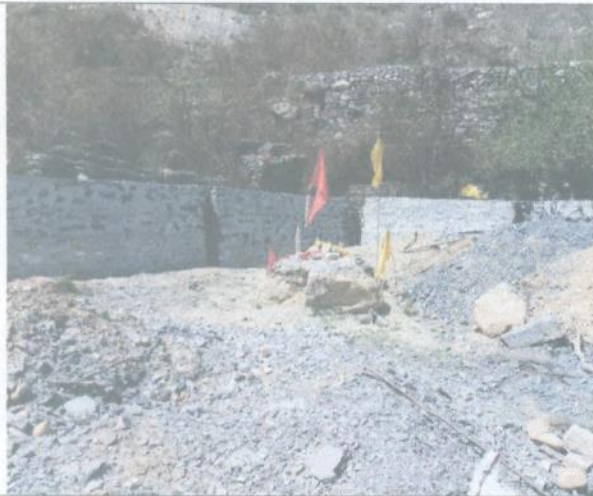
Ruined Temple Remains

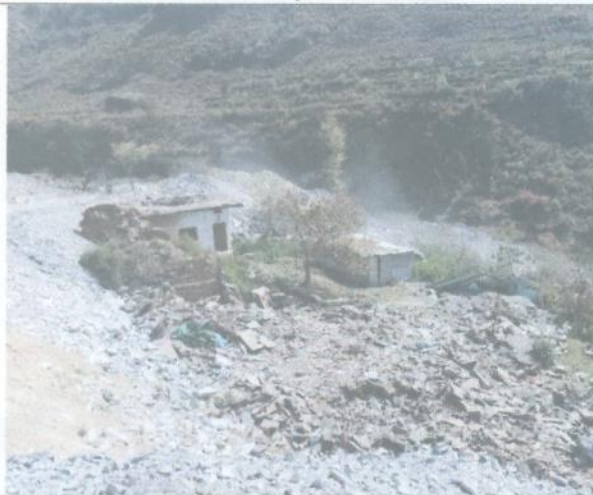
Remains of Ruined Houses

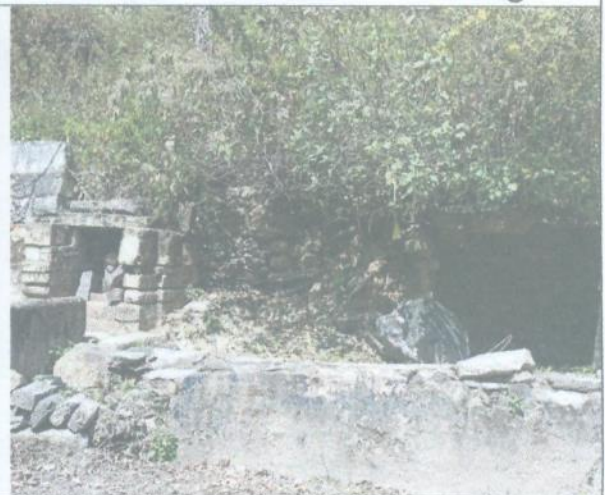
Ruined structure

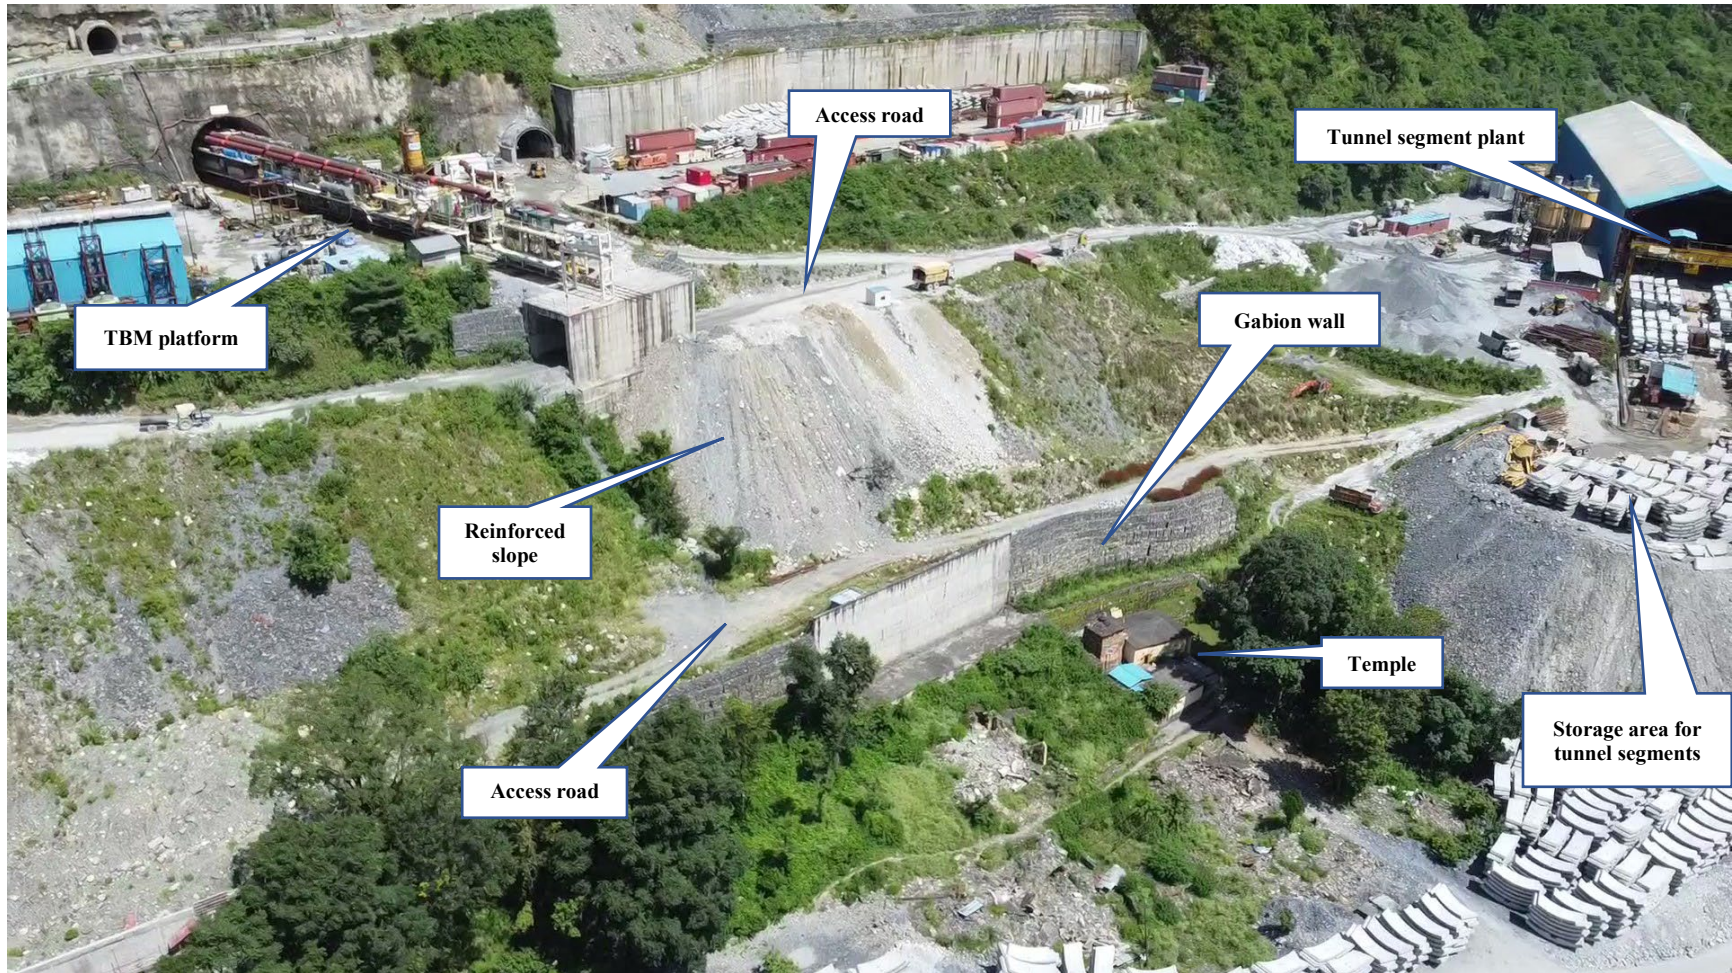
Muck is not being dumped behind the temple or in its immediate vicinity. What the Requesters erroneously identify as “muck dumping” behind the temple is in fact gravel used to fill in and reinforce the slope behind the temple, which supports an access road. The gabion wall has been constructed to protect the temple from any slippage of this slope. As seen in Photo 1 below, vegetation has already begun to grow and cover the area, disproving the claim of muck dumping taking place there. Both access roads are in use, which would not be possible if muck were being dumped, in particular in the area near the lower road. As explained below in more detail, the area around the temple will be revegetated and stability of slopes is being duly monitored.

Photo 1: Aerial photo of the temple complex and the surrounding project works (August 26, 2022). No muck is being dumped behind the wall to the north of the temple complex (i.e., behind the gabion wall).

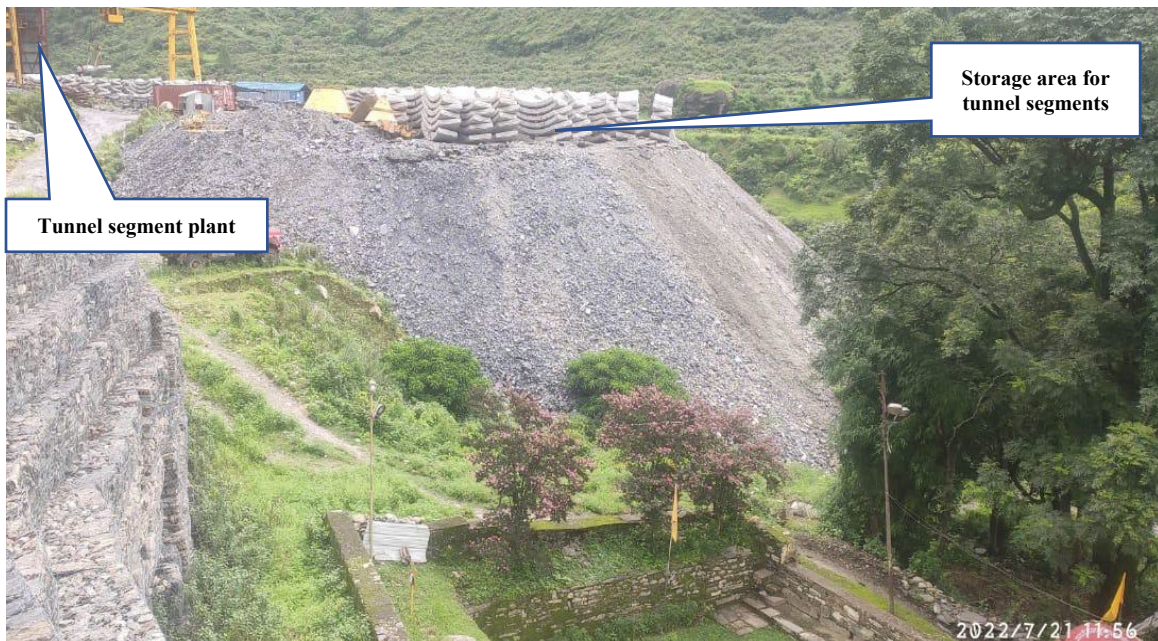
35. ***The same applies to the gravel platform visible to the right of the temple (see Photo 2).*** This gravel has been deposited there one time only, to create a platform for the concrete plant that is casting the segments for the headrace tunnel. The completed segments are being safely stored around the plant until they are used in construction. The area will not be expanded and does not impinge on the temple complex. The use of the area for this purpose also means that muck dumping around the temple would not be possible in any case, as it would interfere with the production and storage of the tunnel segments. The slopes of the platform will also be restored with vegetation once civil works are completed, and Project facilities have been dismantled and removed.

Photo 2. Platform to accommodate the concrete casting plant

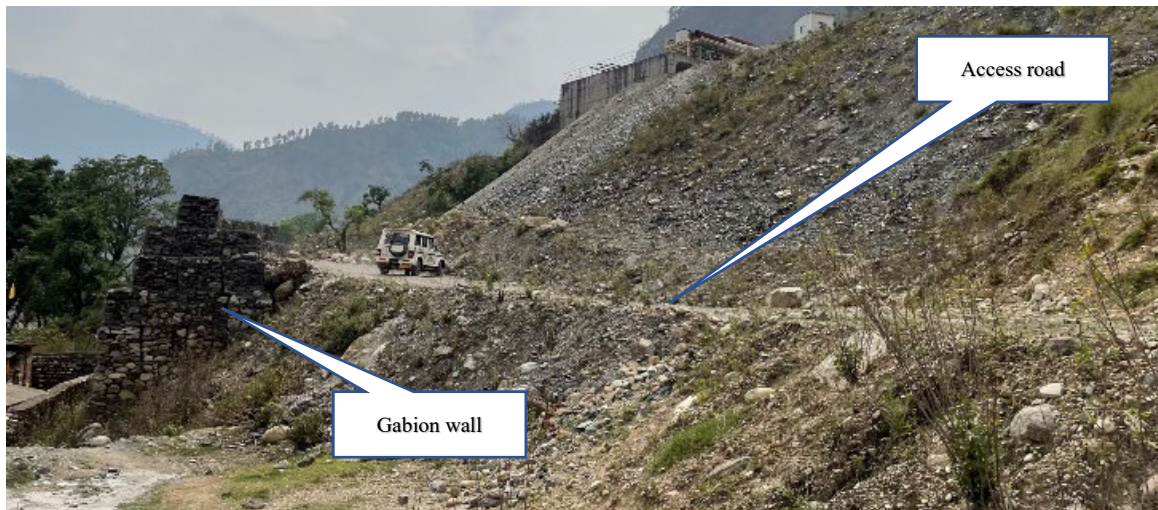
36. ***The gabion wall behind the temple supports the slope and the access road behind the temple (see Photo 3).*** This wall does not serve as a retaining wall against muck, nor was this ever intended. The gabion wall is about 100 m long and up to 9 m thick at the base. This gabion wall was further strengthened with a 100-mm layer of aggregate. As can

Photo 3. Cross-section view of gabion wall with access road to the right and temple complex (not visible) to the left. If the gabion wall was used to protect against stored muck, this access road would not be usable by vehicles.

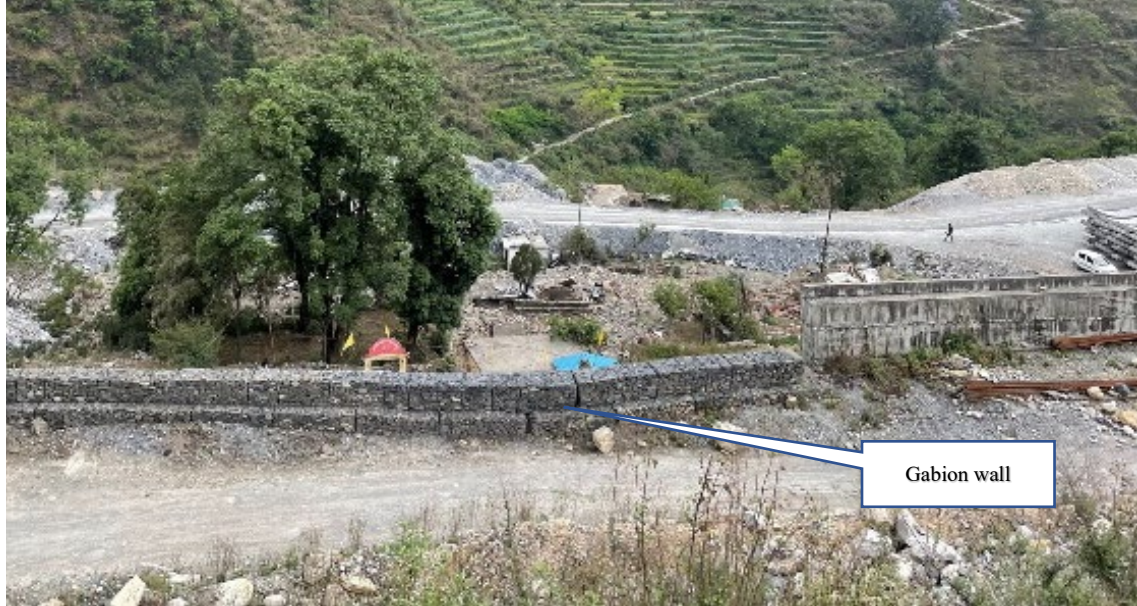
Photo 4. View of the back of the gabion wall (red roof of temple complex visible) showing that no muck is being dumped behind it

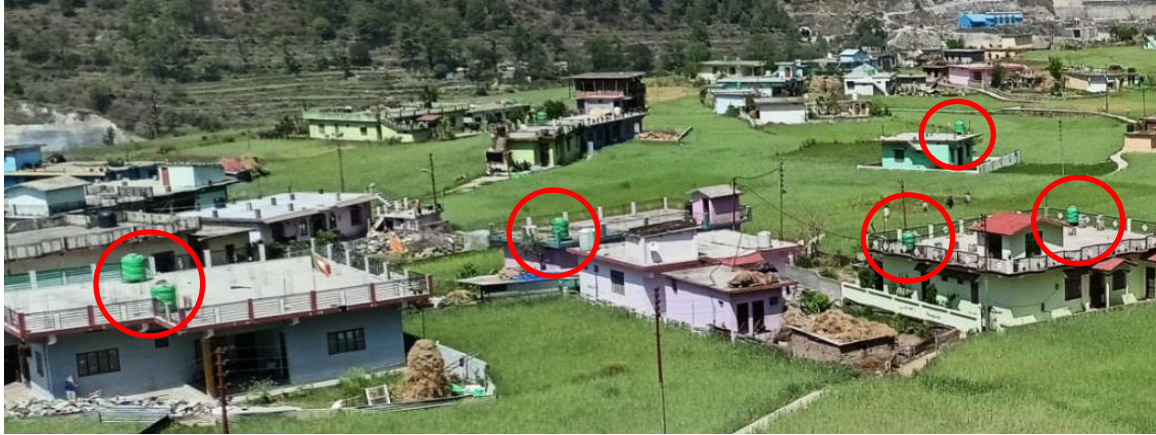
Photo 5: Individual water storage tanks on top of private residences in the Eldana resettlement colony.

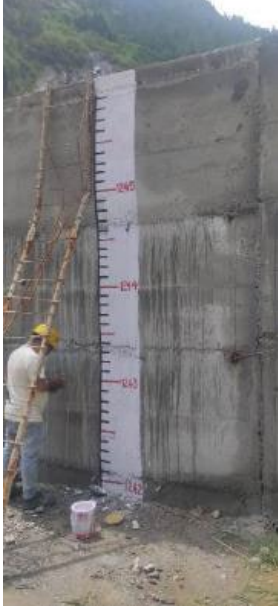
<p data-bbox="873 863 1487 982"><i>Photo 6. Raised height of coffer dam (Following the 2021 Alaknanda flash floods, THDC reviewed the design and raised the height of the coffer dam by 5 m from elevation 1,241 masl to elevation 1,246 masl)</i></p>
