**The Inspection Panel  
Investigation Report**

**Kenya: Lake Victoria Environmental  
Management Project ( IDA Credit. 2907-  
KE and GEF TF 23819)**

**December 15, 2000**

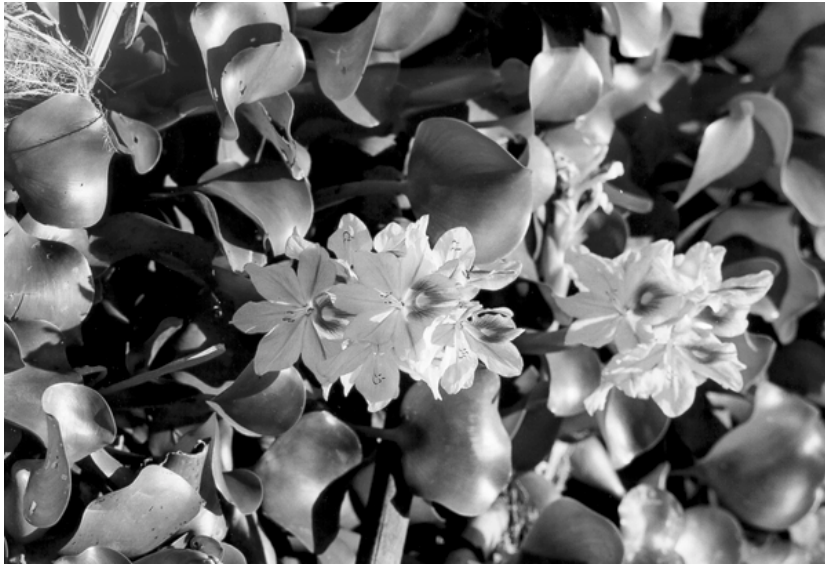
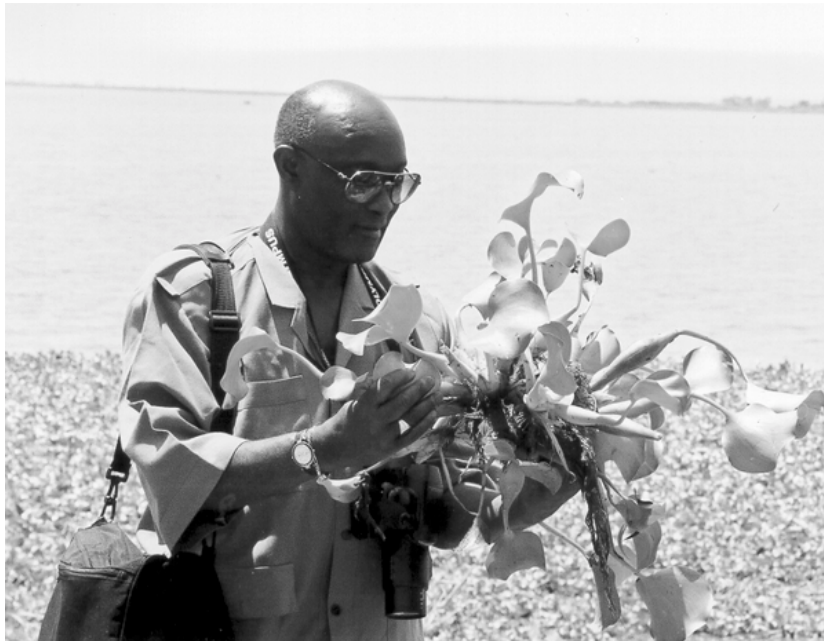
Panel member examining whole plant

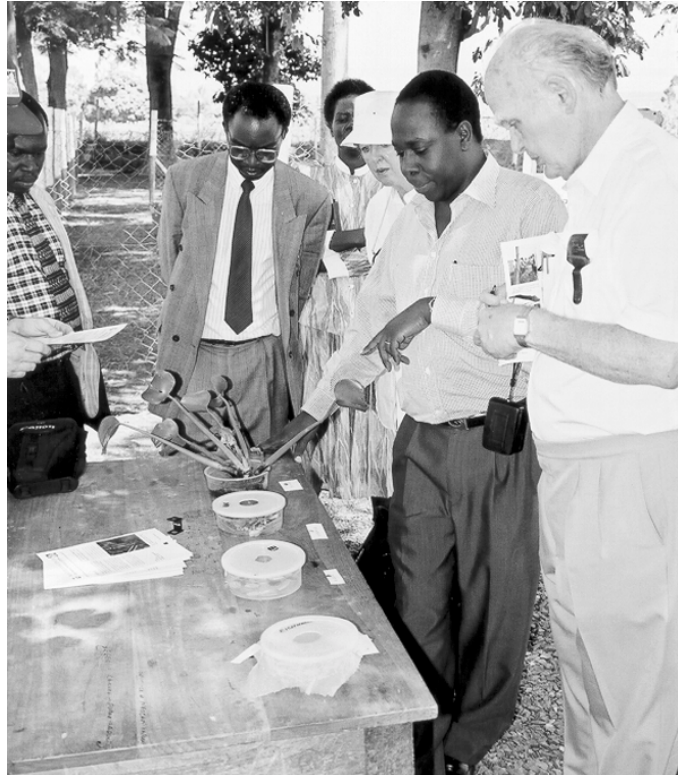
98. Under the LVEMP it was agreed that *Biological Control* was the most sustainable way of managing the uncontrolled proliferation of the plant in Lake Victoria. The biological control program is based on the multiplication and release of two weevil species (*Neochetina bruchi* and *Neochetina eichorniae*), which are well tested for their effectiveness. The adult beetles feed on the leaves and place the plant under stress through excessive transpiration. The eggs of the beetles are laid on the leaves and feed on the plant tissue. This creates further stress on the plant and enables pathogens to establish themselves as the larvae pupate on the root in the water and result in high weevil population capable of placing further stress on the water hyacinth so that it does not flower and therefore does not set seed. Furthermore, the speed with which vegetative reproduction occurs is greatly decreased and, in many cases, the plant population is reduced by thirty to fifty percent.

99. Biological control requires the establishment of mass rearing capacity in units around the shores of the Lake. It also requires a well-coordinated field release program involving local communities and an effective monitoring and training program. The agricultural research organizations of the three riparian countries (the Kenya Agricultural Research Institute (KARI), the Uganda National Agricultural Research Organization (NARO) and the Tanzania Department of Research and Training) were charged with these responsibilities.

Staff of Kari explaining the biology and the weevils rearing project to the Inspection Panel team.

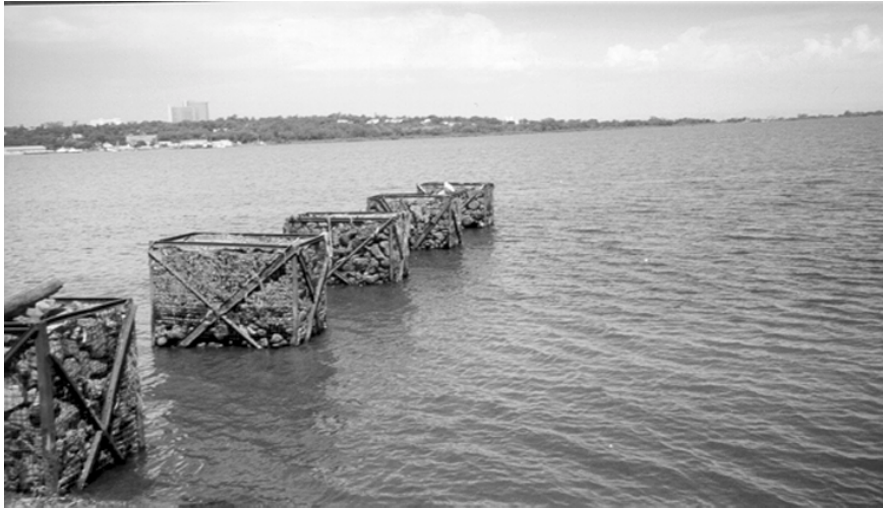
124. During its second visit in July-August, 2000, the mat had virtually disappeared not only from the site of mechanical shredding, but also far beyond it. The reasons for this were a matter of considerable discussion and opinions varied widely. Some attributed it to high water levels and record wind and wave action linked to the El Nino phenomenon. Some attributed it to the biological control

program which was in progress at the time. Some attributed it to a combination of the above and other factors. The question remains marked by uncertainty.

Picture from the same site where Water Hyacinth has virtually disappeared in July 2000

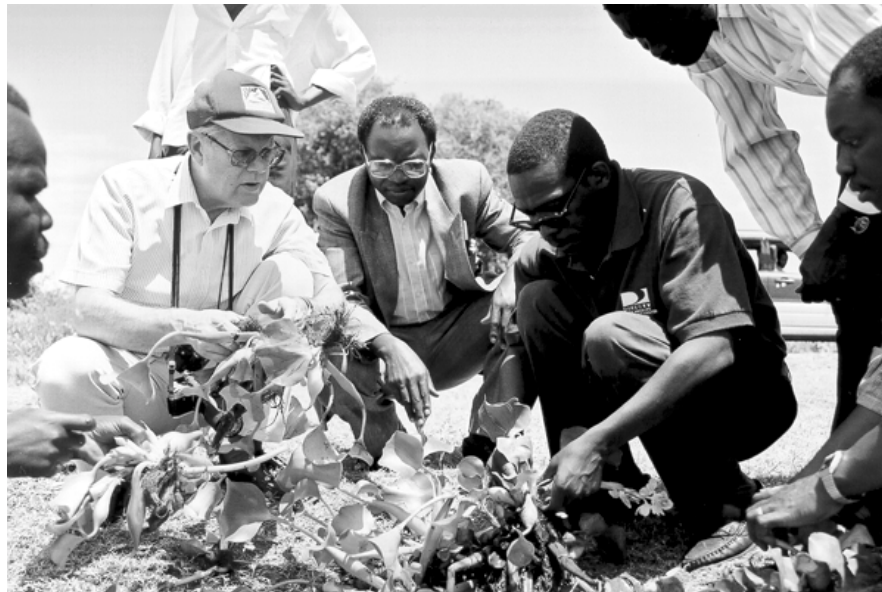
Panel Team Member discussing with Kenya LVEMP scientists the recurrence in July 2000 of water hyacinth in parts of Nyanza Gulf.

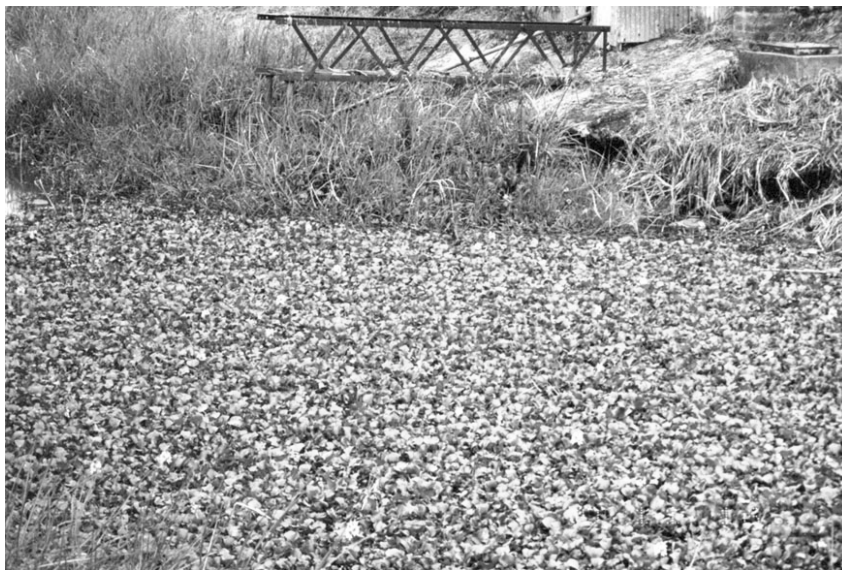
126. The fact that it was premature to declare victory was soon confirmed by the Panel. During its visit to parts of the Lake, the Panel discovered patches of floating (and flowering) mats along the banks and elsewhere. It was further confirmed in November, when the Panel received reports that large parts of the Lakeshore around the Nyanza Gulf were again covered by heavy mats of water hyacinth and secondary growth.

Dense concentration of Water Hyacinth and secondary growth along the lakeshore of Kisumu in November 2000

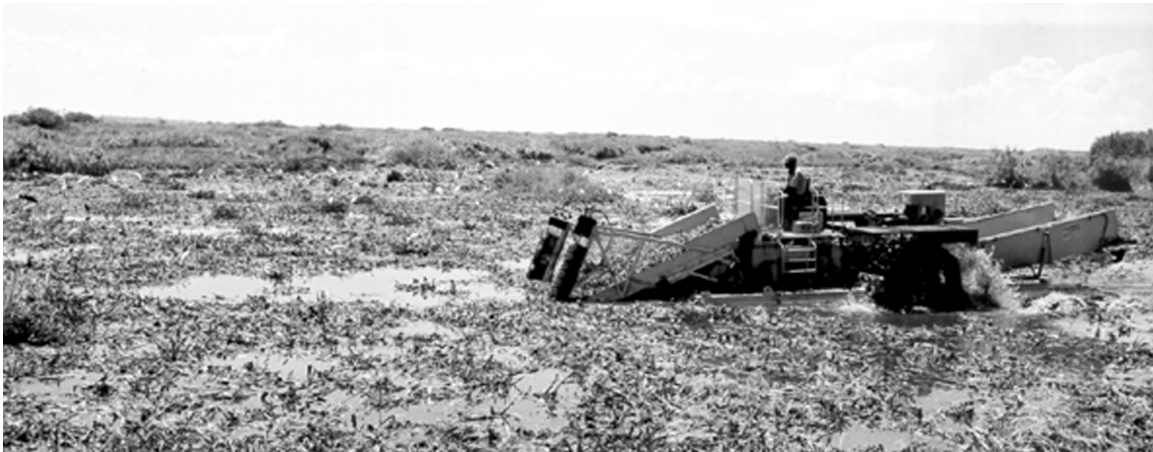
141. In alleging that there was no Environmental Impact Assessment, the Requesters were concerned only with the mechanical shredding of water hyacinth and its dumping into the Lake. They stated that “*No Environmental Impact Assessment (EIA) has been done on the likely impact of the method adopted by the Project of the mechanical removal of the water hyacinth, to wit, the shredding and sinking of the weed to the bottom of the Lake.*”<sup>22</sup> They proceeded to list the damage or harm which they believed could result from the sinking of the weed in the Nyanza Gulf waters.<sup>23</sup>

Aquatic plant shredder at work in the Nyanza Gulf where harvesting and dumping is taking place

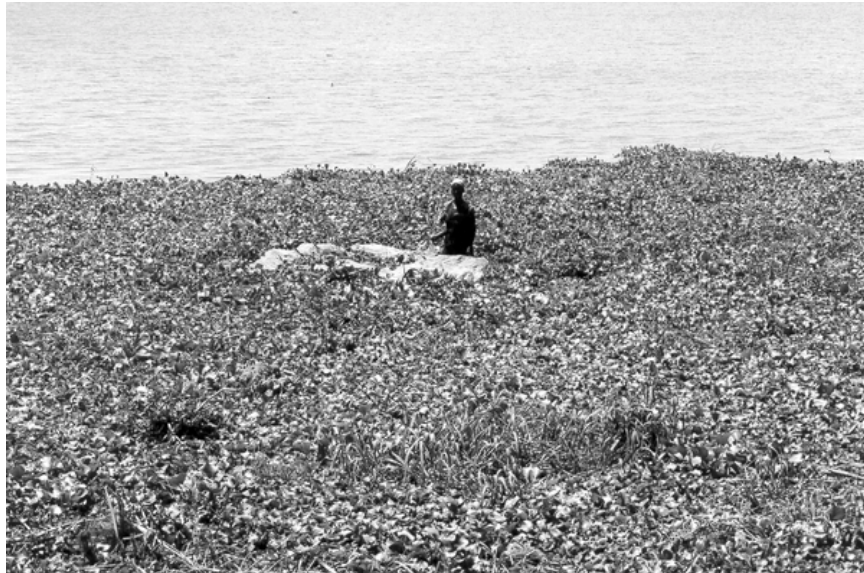
Fisher women using the Water Hyacinth to shelter their nets

(iii) In a continuing program to manage the spread of the water hyacinth, is it possible to find ways to enable the harvesting and removal of the small quantities needed? If so, the harm could be avoided and, over time, the potential benefits of utilization might be realized. It would seem to be worth another look.
